00/00/0000
RE: 1111 Sample
Dear Buyer,

SUMMARY REPORT

INSPECTION REPORT

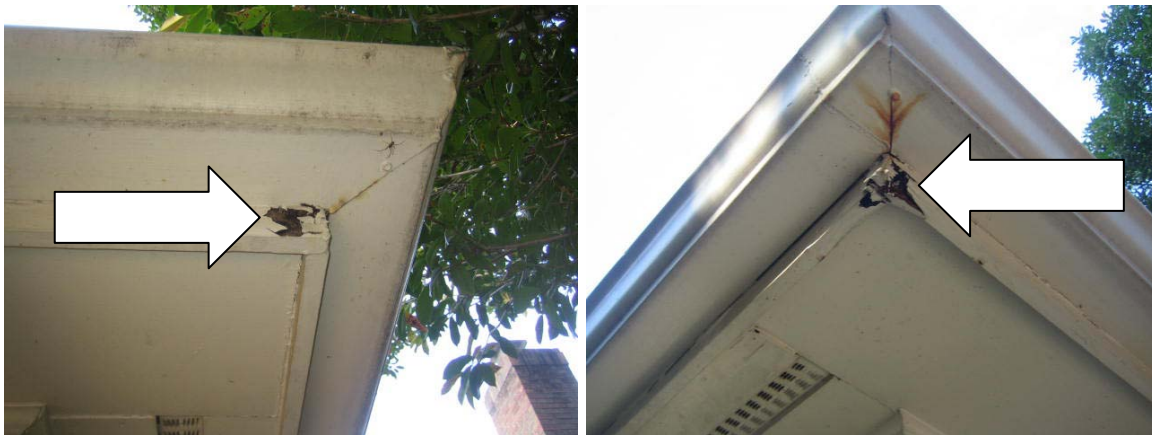
- Wood rot and/or decay damage found on the roof fascia boards in the following location/s of the property: front at the garage and porch areas; left at the middle area. A Wood rot and/or decay is water damage from a heavy and constant exposure that encourages the growth of fungi and bacteria, usually from delayed home maintenance (painting and/or sealing). Fascia board damage is often also caused from damaged and/or deteriorated gutters. Recommend a qualified Contractor evaluate further and repair/replace where necessary.

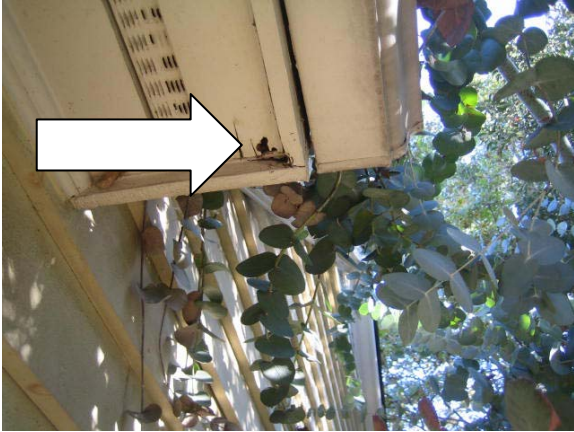
- Wood rot was found in one or more areas on soffit boards on the left side of the house. A qualified contractor should evaluate and make repairs as necessary, replacing all rotten wood.

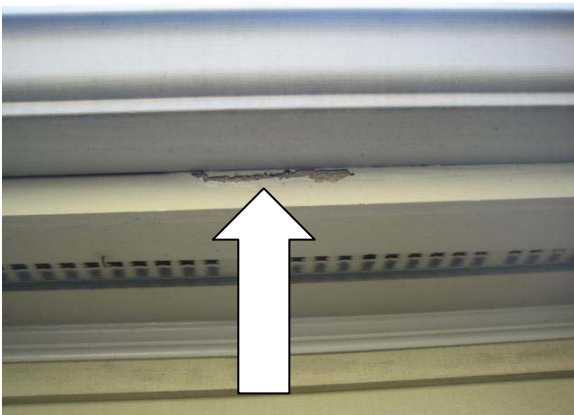
- The paint coat was damaged or bubbling on the fascia board all around the house. A qualified contractor should evaluate the coating and corrected as needed to prevent wood board from the future deterioration.

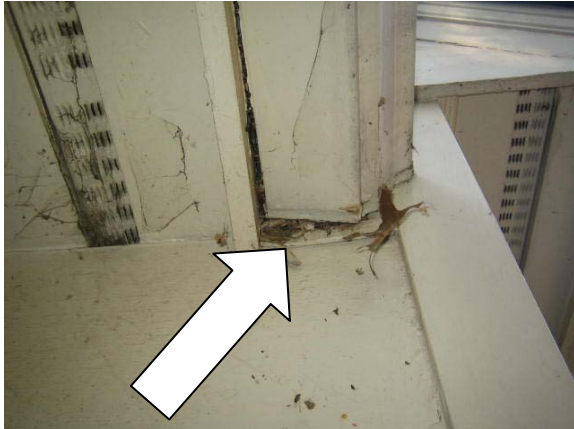
- Decomposition (rot damage) of wood siding was observed in the following locations on this property: over the front patio under the gutter end. A. Wood siding, unless it is a naturally decay resistant species, requires routine painting or sealing. A poorly applied coat of paint may prove harmful by trapping moisture and causing rot. Proper caulking is also important. Recommend repair/replace all decomposed(rotted) wood siding panels identified above, and any other siding panels that may be damaged, which may only become identified by carefully examining each individual panel, which is beyond the scope of our Inspection.

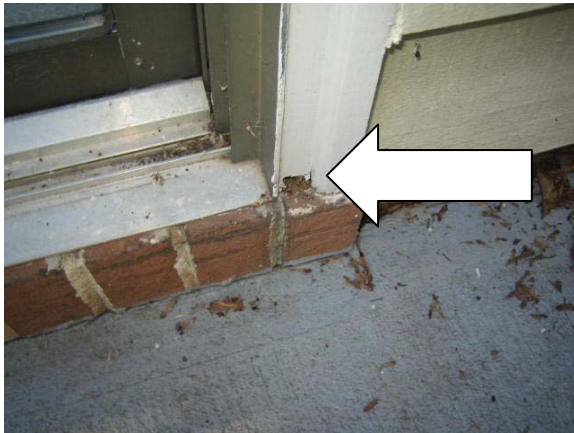
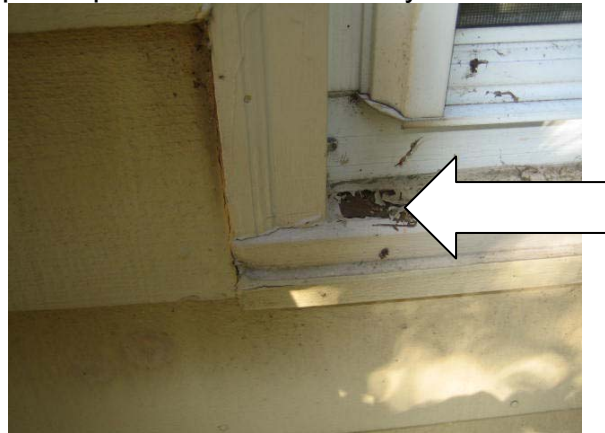
- Wood rot and/or decay damage found on the casing and/ or sill around the doors/windows in the following location/s of the property: front window on the left side of the house, garage door and rear sliding door. Recommend a qualified Contractor evaluate further and repair/replace where necessary.

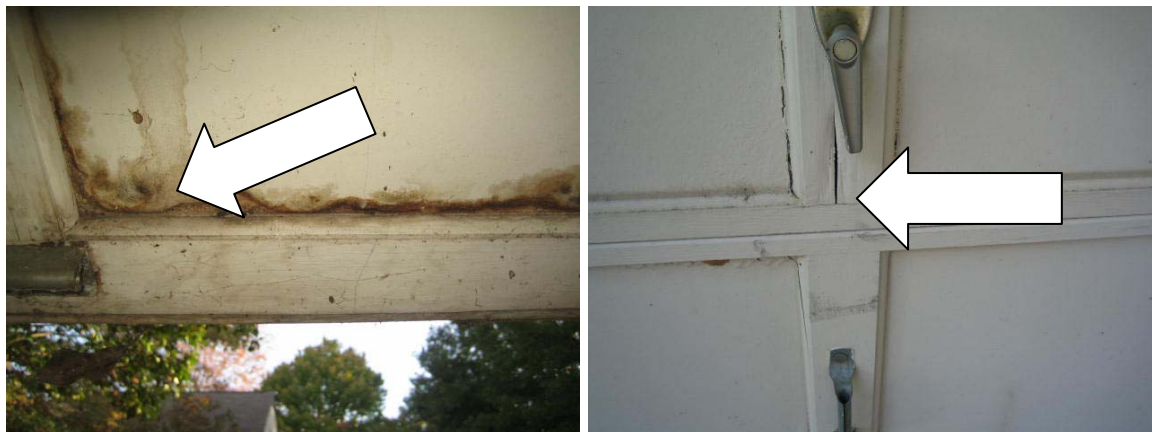
- The garage vehicle has a wood rot damaged/cracked framing and panels at the several areas. Recommend repair/replace as required.

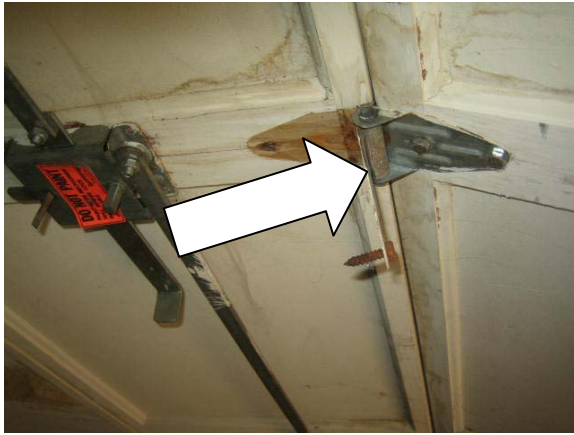
- One hinge between garage door panels was loose. This should be repaired.

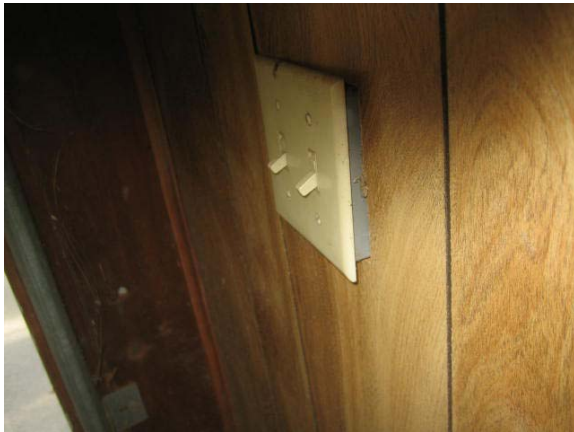
- The garage vehicle-door track wheels are noisy when the door opens and/or closes. Recommend lubricate or adjust track wheels and inside tracks as required.
- The electrical double switch was loose at the wall point at the front part of the garage. Electrician should properly secured switch.

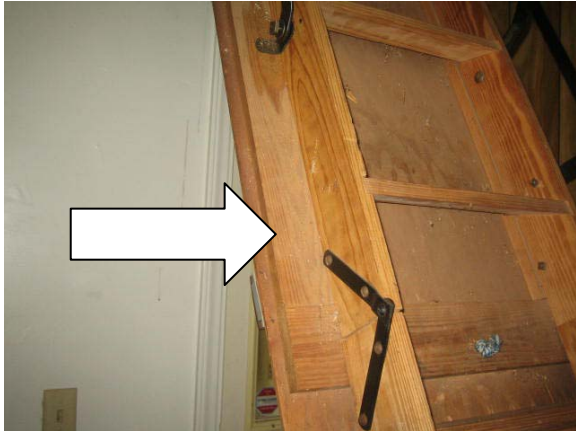
- The attic access pull down door over the attached garage doesn't have a one-hour fire rating. Wall and ceiling surfaces in an attached garage should be fire rated for one hour to prevent or slow the spread of fire from the garage to interior living spaces. This door should be replaced or coated with a material that has a one hour fire rating. A General Contractor should determine the necessary corrective measures.

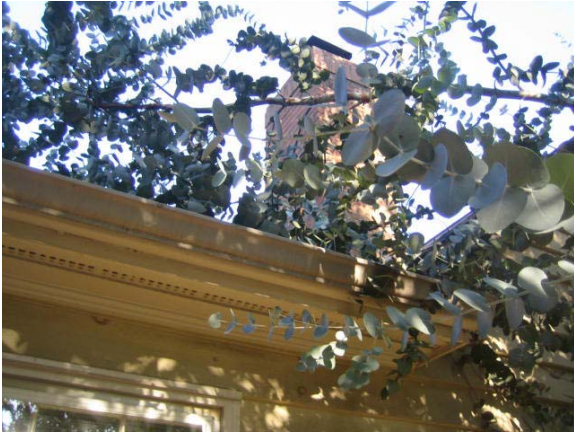
- Trees and/or shrubs are in contact with or are close to the roof edge(s) in one or more areas. Damage to the roof may result, especially during high winds. Vegetation can also act as a conduit for wood destroying insects. Vegetation should be pruned back and/or removed as necessary to prevent damage and infestation by wood destroying insects.

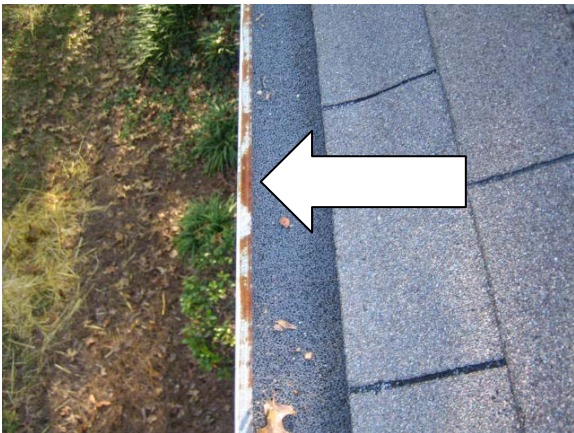
- The gutters are rusted and in poor condition, and should be evaluated and repaired or replaced if needed by specialist.

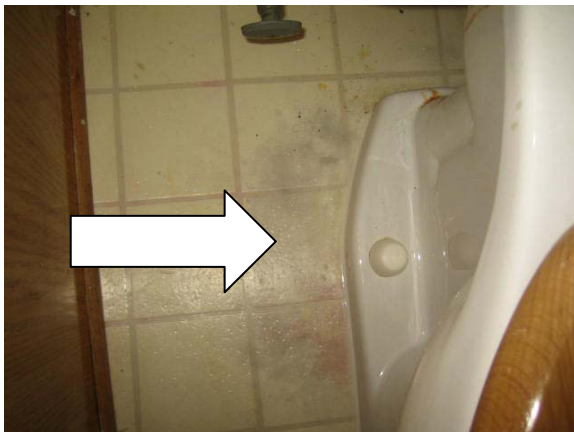
- The wax ring that seals the closet bend of the toilet was leaking, as indicated by the stains and water around the base of the toilet in the hallway bathroom. A Licensed Plumbing Contractor should evaluate the toilet and repair as needed.

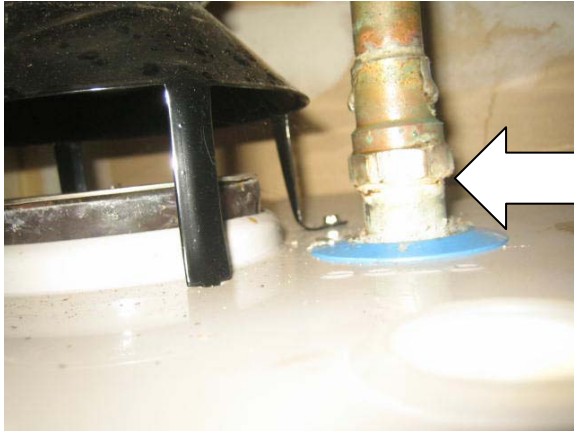
- The copper pipe was connected directly to the galvanized nipples on the water heater. Two dissimilar materials should be connected through dielectric union to prevent corrosion. A Licensed Plumbing Contractor should be evaluate the water heater installation and determine the necessary corrective measures.

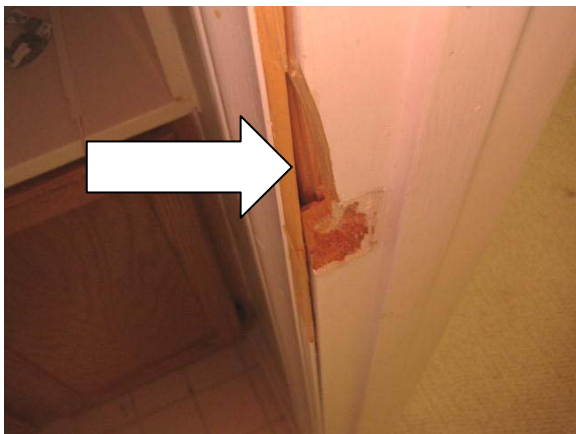
- The window in the front left bedroom could not stay open and has a detached or broken tension spring, bar, or cable that should be repaired or replaced. The tension spring, bar, or cable is a safety device that holds the window in the open position.
- Door was bound at the top jamb in the rear left bedroom. The door should be adjusted for proper operation.
- The door jamb was broken in the master bathroom. The door should be repair or replaced as needed.

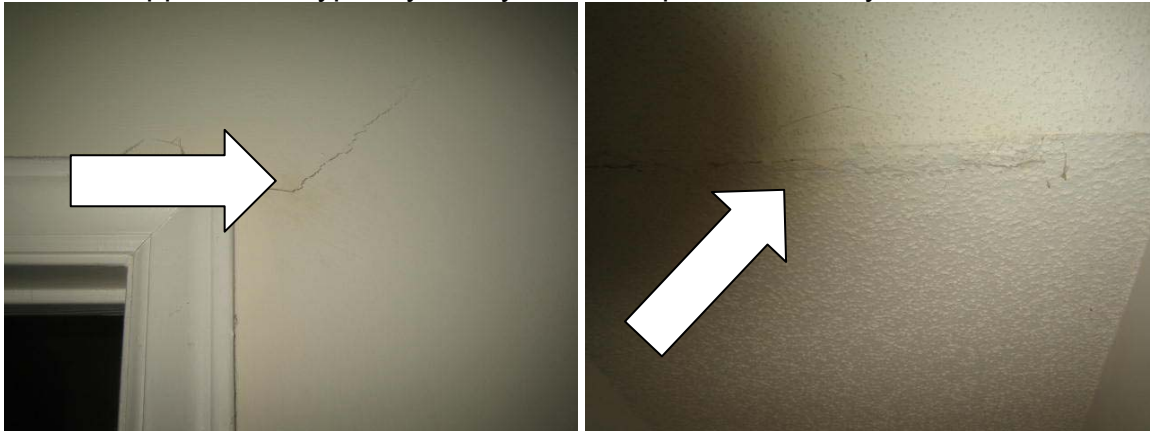
- Minor settlement cracks seen on the drywall in some locations on the ceiling in the family room and wall in master bedroom. Recommend having a qualified Contractor repair as required. Typical repairs may include covering the small visible gaps found with fiberglass drywall tape and coating with drywall compound where necessary. Client should also be aware that such cracks can reappear, and typically if they are not repaired correctly.

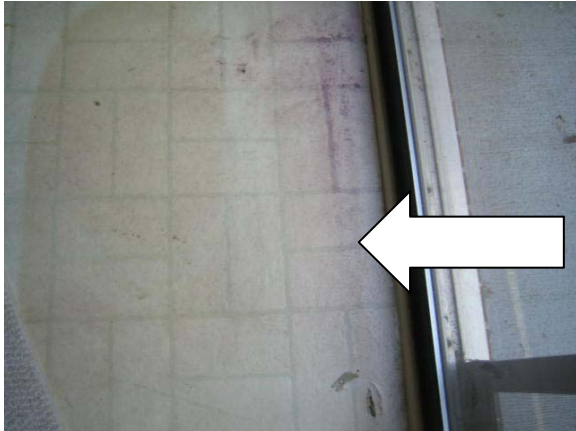
- The floor covering was pulled up and discoloring along the sliding door in the kitchen. A General Contractor should determine the cause of the covering damage and the necessary repair.

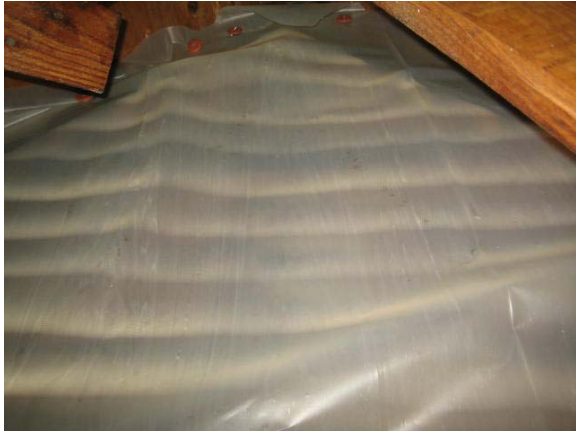
- The gable attic vents were covered with plastic. The plastic should be removed for proper attic ventilation.

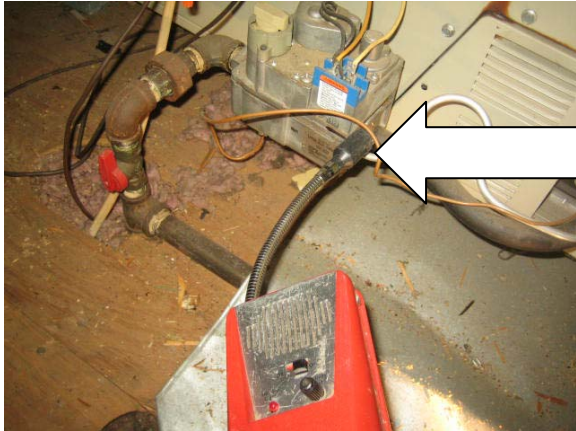
- The gas leak was detected around control valve on the furnace. A Mechanical Contractor should evaluate the valve, pipes and determine the necessary repairs.

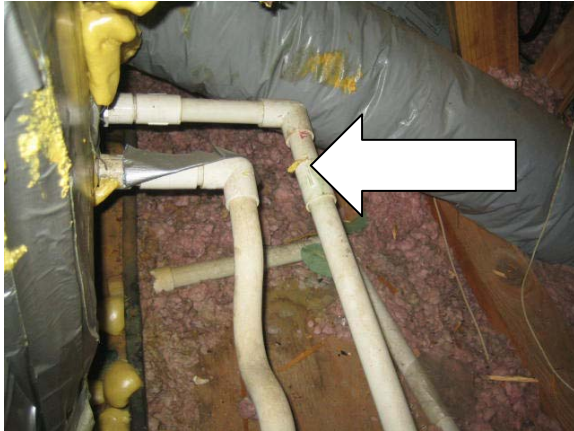
- The condensate primary line was not trapped. HVAC condensate lines must be trapped and not in contact with wet drain inlets to prevent the possible migration of bacteria and mold into the air-handling system.
