Home Inspection Report

File Number: **504-112011-0410**
Address of Inspection: **575 Inspection Dr**

**RE: 575 Inspection Dr
Fairview, PA 16415
Inspection #: 504-112011-0410**

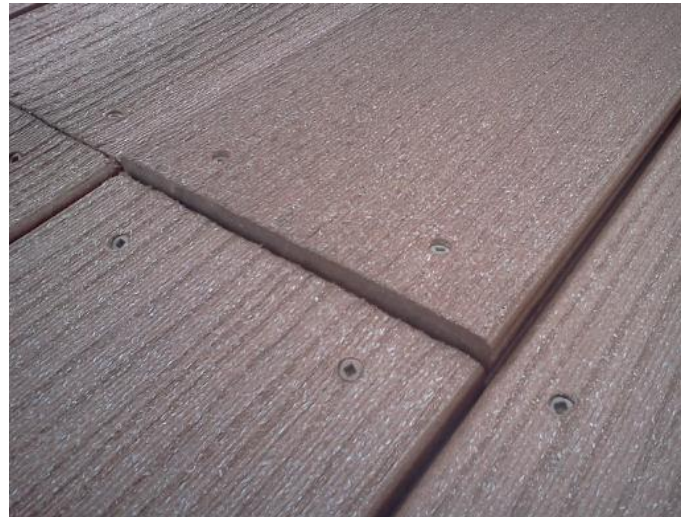
- There was a deck located in the back of the home. There did not appear to be significant deterioration of the material. The railings around the deck and stairs were securely attached to the deck or stairs. NOTE: One piece of composite decking was not fully nailed down at one end and was lifting slightly

There was a deck located in the back of the home. There did not appear to be significant deterioration of the material. The railings around the deck and stairs were securely attached to the deck or stairs. NOTE: One piece of composite decking was not fully nailed down at one end and was lifting slightly.

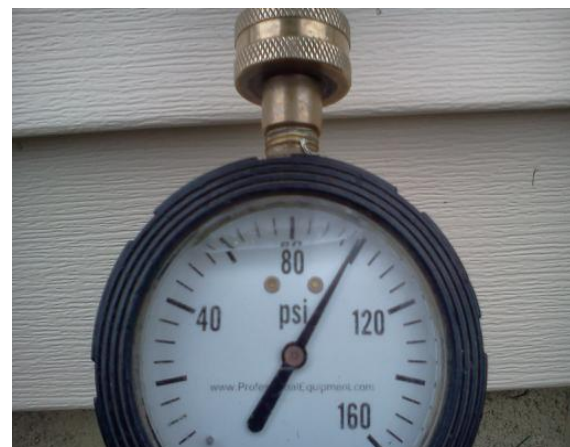
- High public water pressure of 100 psi or more was observed. Elevated water pressure can lead to problems with faucets, connections, leaks, advanced deterioration of supply system, releasing of the T&P valve on the water heater, etc. Though many homes function well with elevated water pressure, many plumbing contractors will recommend that a water pressure reducing valve (and possibly an expansion tank) be installed near the water meter when the incoming water pressure is 80 psi or higher

NOTE; High public water pressure of 100 psi or more was observed. Elevated water pressure can lead to problems with faucets, connections, leaks, advanced deterioration of supply system, releasing of the T&P valve on the water heater, etc. Though many homes function well with elevated water pressure, many plumbing contractors will recommend that a water pressure reducing valve (and possibly an expansion tank) be installed near the water meter when the incoming water pressure is 80 psi or higher.

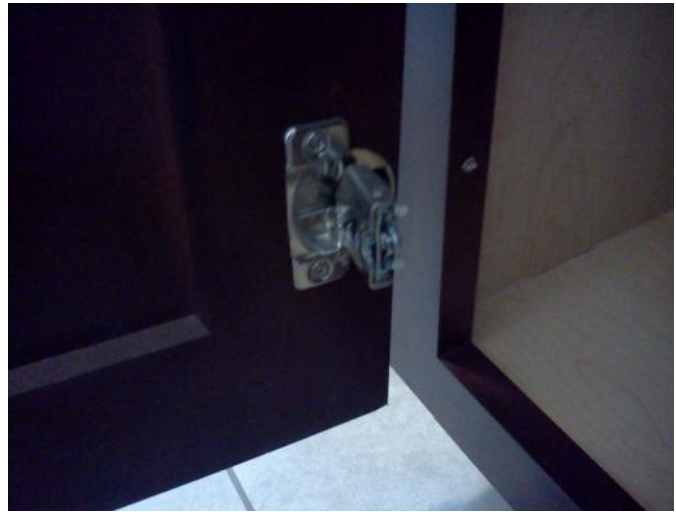
- The 1ST FLOOR bathroom was ventilated by a window and ceiling fan that was functional at the time of inspection. It was possible to see where the fan vented to. NOTE: One of the bathroom sink vanity doors has a hinge that is not connected to the vanity cabinet.

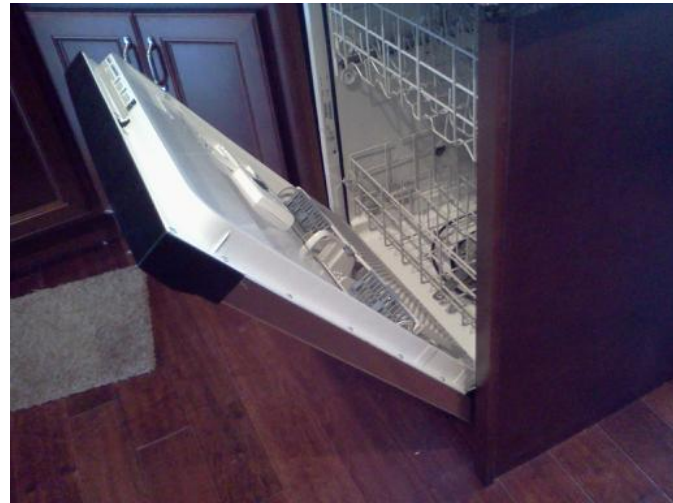
- The Whirlpool dishwasher was observed through a complete cycle and did appear to be functional when set on the "wash" and "drain" cycle. NOTE: The dishwasher door did not fully open - it was catching on some metal under the dishwasher.

The Whirlpool dishwasher was observed through a complete cycle and did appear to be functional when set on the "wash" and "drain" cycle. NOTE: The dishwasher door did not fully open - it was catching on some metal under the dishwasher.
