# Home Inspection Report

File Number: **555-555-55555**  
Address of Inspection: **4444 New Home Drive**

**RE: 4444 New Home Drive**  
**Erie, PA 16506**  
**Inspection #: 555-555-55555**

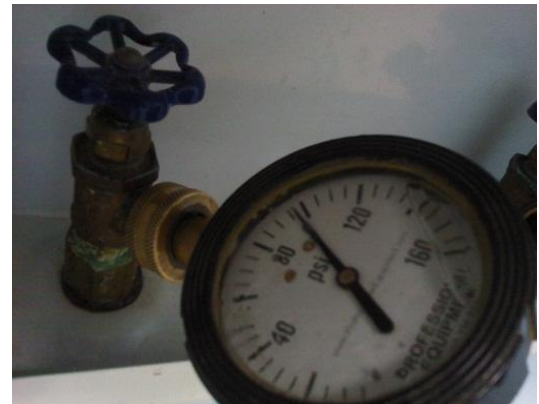
- High public water pressure of 95 psi or more was observed. Elevated water pressure can lead to problems with faucets, connections, leaks, advanced deterioration of supply system, releasing of the T&P valve on the water heater, etc. Though many homes function well with elevated water pressure, many plumbing contractors will recommend that a water pressure reducing valve (and possibly an expansion tank ) be installed near the water meter when the incoming water pressure is 80 psi or higher.
- A very small leak in the plumbing drain piping was observed under the kitchen sink, at the basement ceiling below We recommend repair by a plumbing contractor

**NOTE:** *A very small leak in the plumbing drain piping was observed under the kitchen sink, at the basement ceiling below We recommend repair by a plumbing contractor.*

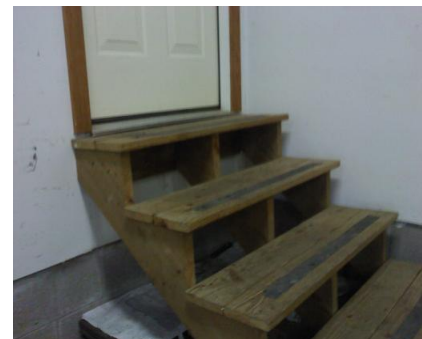
- Hand railings were not present at the steps present inside the garage. This is a safety concern that should be addressed

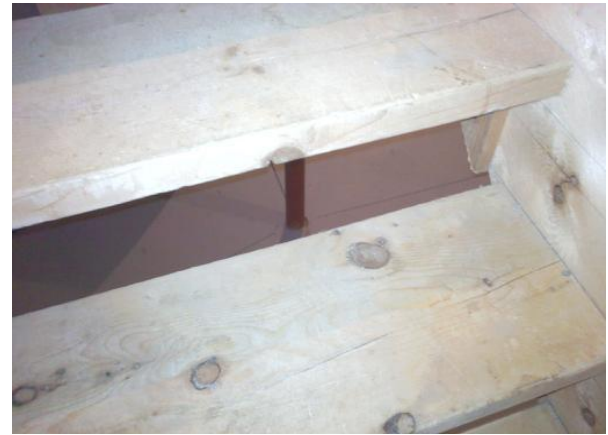
- At the steps leading down to the basement, 2- 3 of treads are cracking. For safety, we recommend immediate repair to prevent possible injury.
- The Jacuzzi-style tub did not appear to be on a circuit that was GFCI controlled. A reasonable effort was made to find a GFCI receptacle, or GFCI circuit breaker, that was connected to this tub. For safety, any Jacuzzi-style tub present in the home must be on a circuit that is GFCI controlled. We recommend further evaluation and/or repair by an electrician

***NOTE:** At the steps leading down to the basement, 2- 3 of the wooden treads are cracking. For safety, we recommend immediate repair to prevent possible injury.*

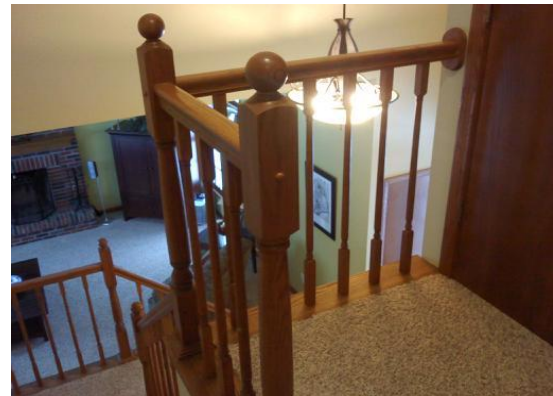
- The balusters / spindles on the stairway leading to the 2nd floor, and at the 2nd floor landing, appeared to be more than 4-inches apart, which can be a safety concern for small children and/or pets. Ideally, they should be a maximum of four inches apart. In homes older than a few years it is not uncommon to find them wider apart than 4". If safety for small children and/or pets is a concern, we recommended modifying the balusters. There are instances of children and pets getting caught between balusters with resulting personal injury

**NOTE:** *The balusters / spindles on the stairway leading to the 2nd floor, and at the 2nd floor landing, appeared to be more than 4-inches apart, which can be a safety concern for small children and/or pets. Ideally, they should be a maximum of four inches apart. In homes older than a few years it is not uncommon to find them wider apart than 4". If safety for small children and/or pets is a concern, we recommended modifying the balusters. There are instances of children and pets getting caught between balusters with resulting personal injury.*
