# Home Inspection Report

File Number: **555-555-55555**  
Address of Inspection: **3333 New Home Drive**

**RE: 3333 New Home Drive**  
**Erie, PA 16506**  
**Inspection #: 555-555-55555**

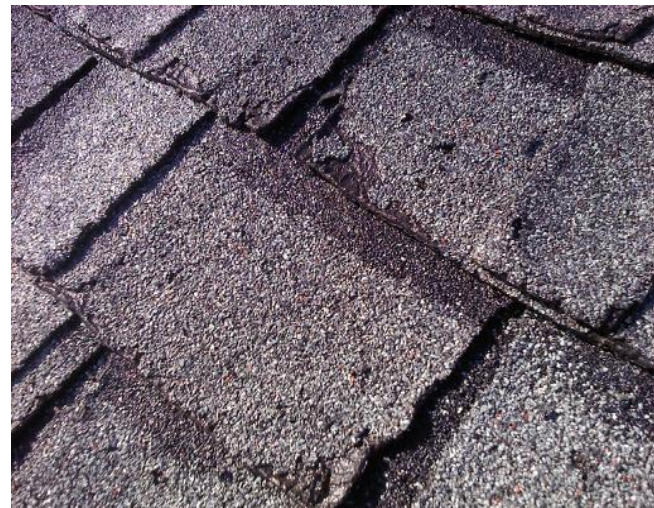
- There was serious curling and serious surface wear observed on the roof shingles of the rear bedroom at the time of the inspection. These conditions indicate the roof shingles of the rear bedroom were at the end of their useful life

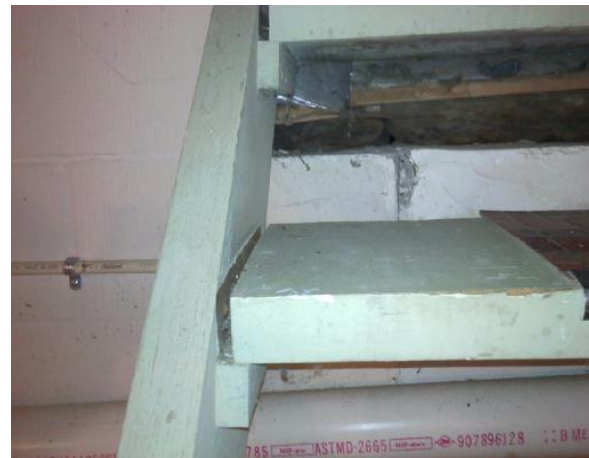
- At the steps leading down to the basement, one or more of the wooden side stringers are pulling away from some of the wooden step treads. Gaps were visible between the step treads and the side stringers. This is not uncommon when nails are used to construct the steps, but this condition is considered to be a potential safety issue. For safety, we recommend immediate repair to prevent possible injury.

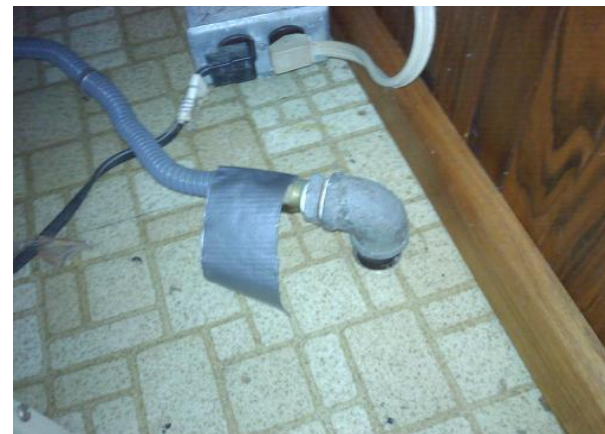
- The smell of natural gas was observed at behind the gas stove in the kitchen. There appeared to be a gas leak in this area. I marked the area with duct tape. This is a safety issue. Recommend further evaluation and/or repair by an HVAC or plumbing contractor.

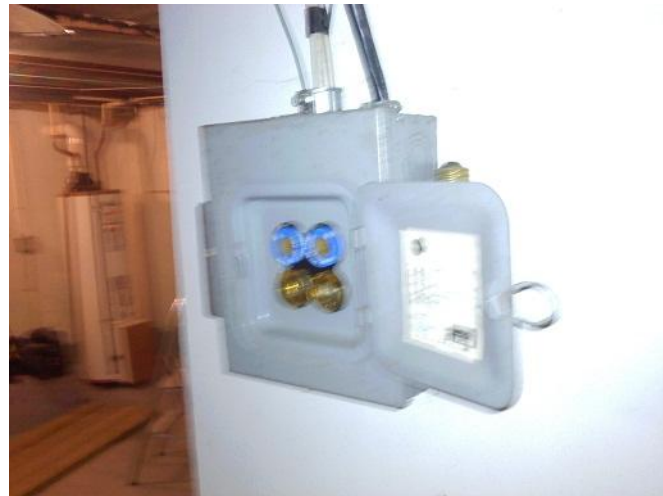
- Two double tapped circuits (breakers or fuses) were present at the sub-panel in the basement. A circuit breaker (unless designed to handle two wires) or fuse with more than one wire attached is called "double tapped". Other than Square D brand breakers, circuit breakers and fuses are typically designed to have a single wire attached to them. Attaching multiple wires under one circuit breaker or fuse can cause nuisance tripping and create poor electrical connections which can loosen over time and cause arc-ing or overheating. We recommend further evaluation and/or repair by an electrical contractor

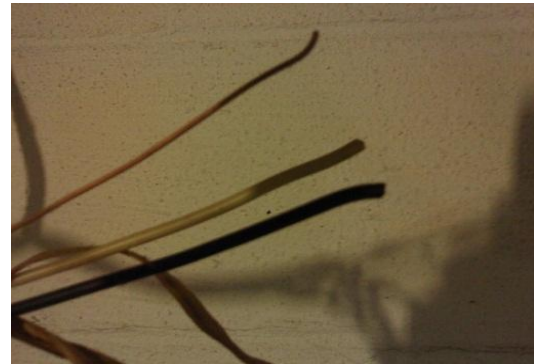
- Exposed live wiring was observed at basement - along rear wall. This is a safety concern. We recommend further evaluation and/or repair by an electrician

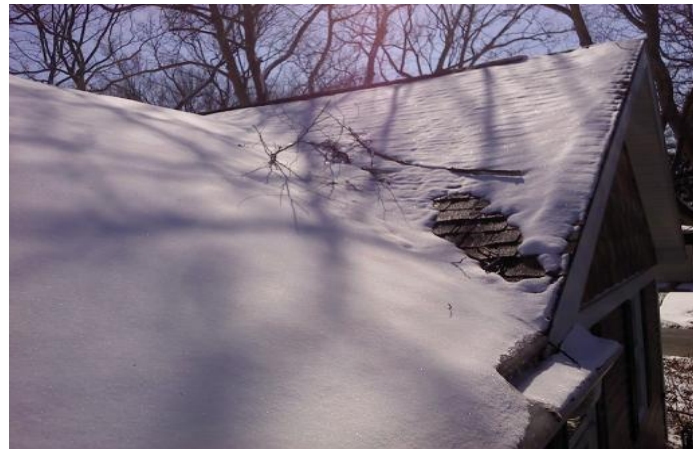
**NOTE:** *If we noted any serious wear, damage, or signs of leakage to any section of roofing, we recommend that you contact one or more roofing contractors for further evaluation and/or a repair estimate.*

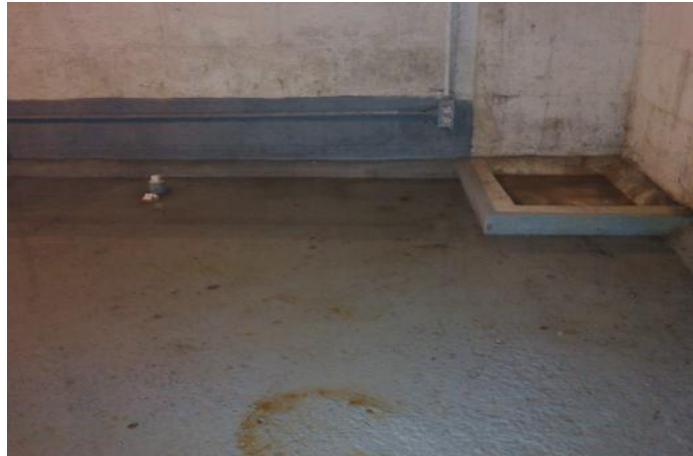
The basement was not dry at the time of the inspection. Many water stains were visible on the walls. Indications of moisture was present on the floor - ponding water near rear wall. A musty odor was present. Efflorescence ( a crusty white-ish residue on masonry walls ) was not visible on the walls. No signs of past flooding were visible at this time.

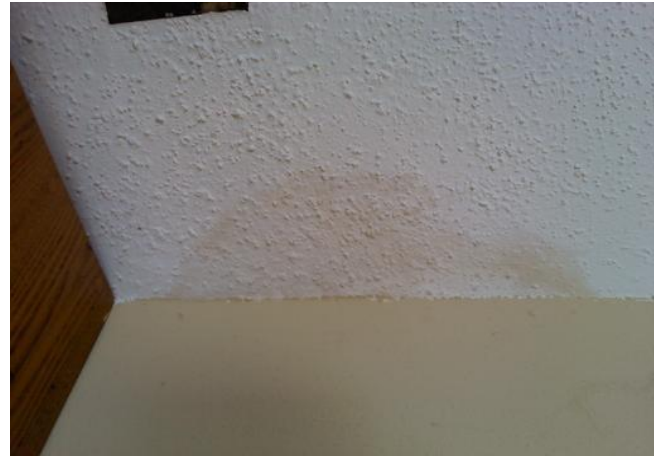
**NOTE:** *Water stains were observed at dining room ceiling(s). These stains were not damp to the touch at the time of inspection. Changes in the stain(s) were not visible during the inspection. Stains do indicate past moisture intrusion. It is unknown as to whether the moisture intrusion is still active or not. We recommend that you ask the seller for information on age and source of stain(s). Source is possibly from skylights or from roof over rear deck.*

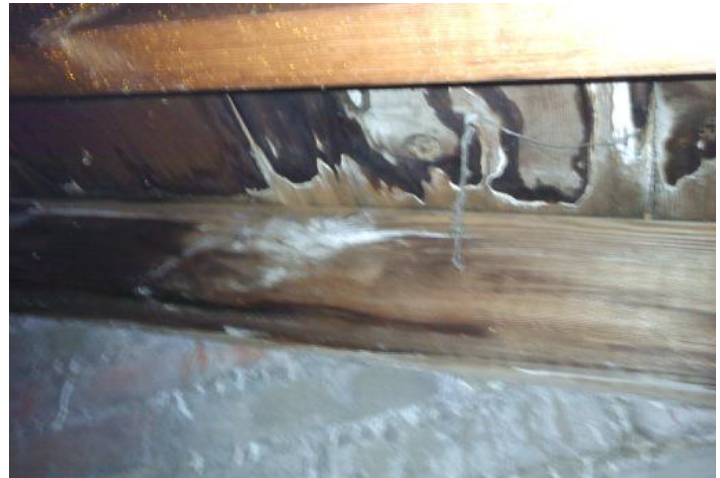
**NOTE:** *Some water staining on wooden roof structure around the chimney and at rear bedroom roof structure was observed in the attic. Some rotted wooden roof structure was not observed. These stains were not damp to the touch at the time of inspection. They are an indication of past moisture intrusion. Without inspecting this area during a prolonged period of rain we cannot determine if the leaking is still active or not. We recommend that you ask the seller for any further information and that you monitor these areas during a heavy rain and make repairs to roof exterior (such as flashing) if needed.*
