Home Inspection Report

File Number: **555-555-55555**
Address of Inspection: **1111 New Home Drive**

**RE: 1111 New Home Drive
Erie, PA 16504
Inspection #: 555-555-55555**

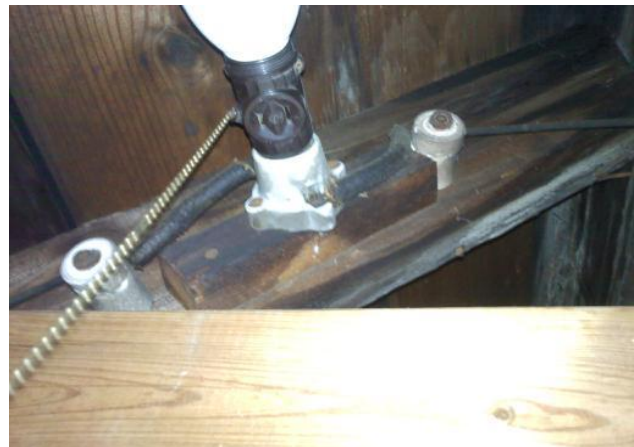
- Active knob & tube wiring was observed at basement ceiling and attic. Due to its age it is considered a safety issue. Any active knob & tube wiring should be further evaluated by an electrical contractor. Without dismantling, I cannot tell you with certainty if it is also present inside the walls, but it is possible given the age of the home. Knob-and-tube wiring was common in

wiring systems installed before 1940. With exposed sections of knob-and-tube wiring, the outer insulation coverings should be checked for broken and open sections. The insulation is often dry and brittle, and chips easily. Exposed areas should be insulated/repared by a licensed electrician, and any modifications to the wiring must be made by a licensed electrician. Knob & tube wiring was designed as an "open-air" system, not to be covered with attic insulation. If any changes or extensions are made, rewiring of that branch circuit might be necessary. In addition, the outlet receptacles of a knob-and-tube-wired system are not grounded.

***NOTE:** Active knob & tube wiring was observed at basement ceiling and attic. Due to its age it is considered a safety issue. Any active knob & tube wiring should be further evaluated by an electrical contractor. Without dismantling, I cannot tell you with certainty if it is also present inside the walls, but it is possible given the age of the home. Knob-and-tube wiring was common in wiring systems installed before 1940. With exposed sections of knob-and-tube wiring, the outer insulation coverings should be checked for broken and open sections. The insulation is often dry and brittle, and chips easily. Exposed areas should be insulated/repared by a licensed electrician, and any modifications to the wiring must be made by a licensed electrician. Knob & tube wiring was designed as an "open-air" system, not to be covered with attic insulation. If any changes or extensions are made, rewiring of that branch circuit might be necessary. In addition, the outlet receptacles of a knob-and-tube-wired system are not grounded.*

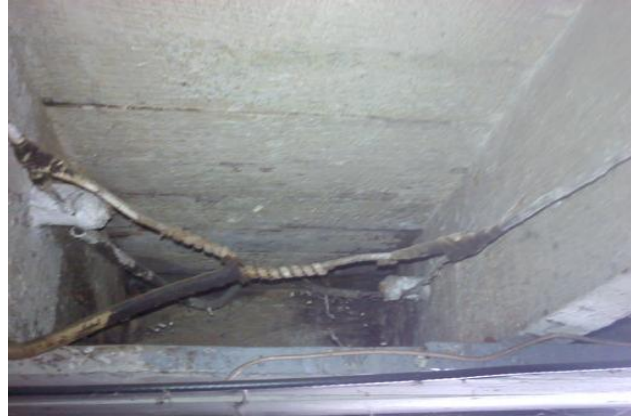
- Missing cover plates for electric junction boxes were observed at the basement ceiling. Cover plates should be installed as a safety measure to prevent access to live wiring

***NOTE:** Missing cover plates for electric junction boxes were observed at the basement ceiling. Cover plates should be installed as a safety measure to prevent access to live wiring.*

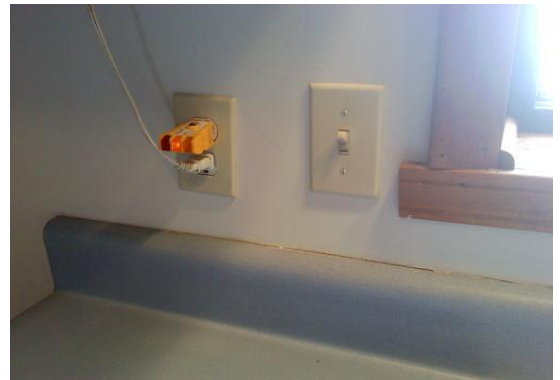
- The GFCI receptacle(s) (outlet) in the basement was not fully functional. Typically, this means that either the "test" and "re-set" buttons were not working OR that the outlet still had electrical power even after it was tripped. In some cases a GFCI receptacle can be tripped, but cannot be re-set. All of these are common problems with older GFCI outlets. We recommend replacement with a new GFCI outlet(s)
- Cracked window glass was observed at 1st and 2nd floors. Cracked glass should be replaced to avoid the potential for injury

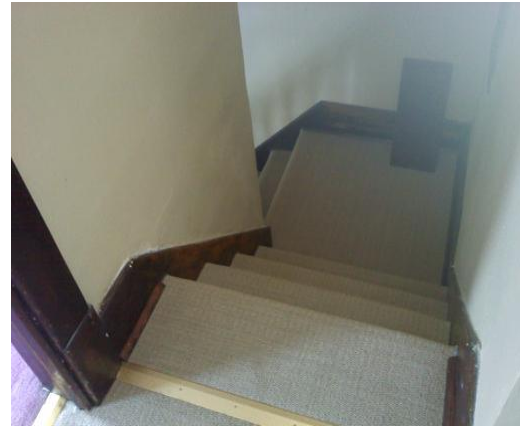
- A hand railing was not present at the steps leading to the 2nd floor

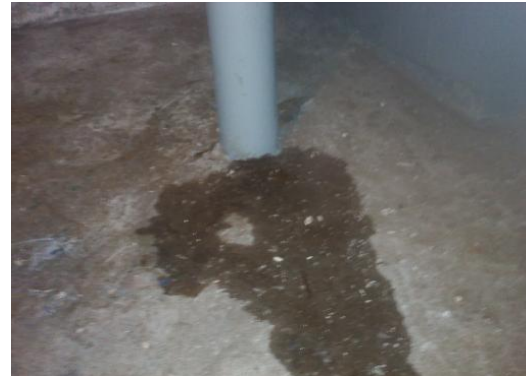
- Vertical cracking & corrosion was visible on the cast iron drain piping stack at basement. Active leaking was visible at the time of inspection. Because of advanced corrosion observed, we recommend further evaluation of piping and/or repair estimate by a plumbing contractor

NOTE: *Vertical cracking & corrosion was visible on the cast iron drain piping stack at basement. Active leaking was visible at the time of inspection. Because of advanced corrosion observed, we recommend further evaluation of piping and/or repair estimate by a plumbing contractor.*

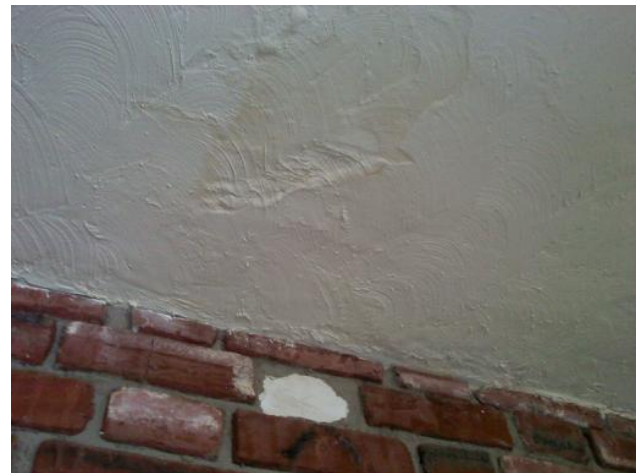
- Water stains were observed at kitchen ceiling(s) under the bathroom. These stains were not damp to the touch at the time of inspection. Changes in the stain(s) were not visible during the inspection. Stains do indicate past moisture intrusion. It is unknown as to whether the moisture intrusion is still active or not. We recommend that you ask the seller for information on age and source of stain(s). If the stain is on a ceiling below a bathroom, we recommend that you seek further evaluation of the bathroom by a plumbing contractor

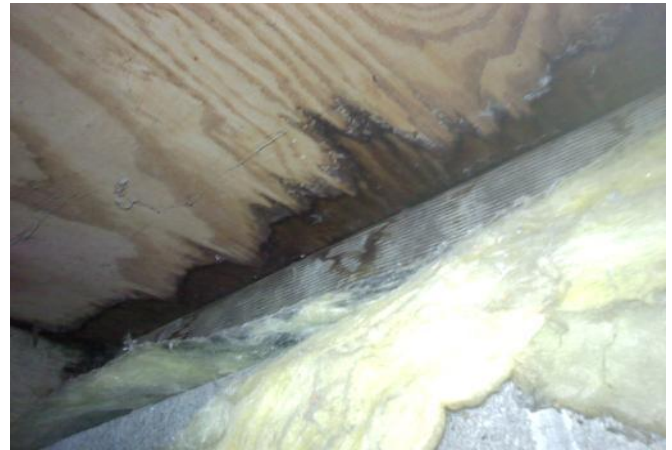
NOTE: *Water staining of floor structure was observed at crawl space ceiling under the 1st floor bathroom shower unit. These stains were not damp at the time of inspection.*

If damp or wet we recommend immediate repair of the source of moisture intrusion. Even if not damp or wet at this time, we recommend that you monitor any areas where water staining was observed. It is beyond the scope of inspection to determine the age or activity of this staining and we recommend that you ask the seller for pertinent information regarding this staining.

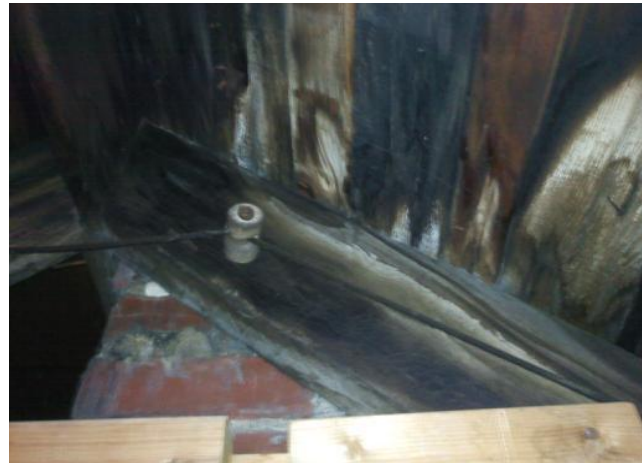
NOTE: Some water staining on wooden roof structure around the chimney was observed in the attic. Some rotted wooden roof structure around the chimney was slightly observed. These stains were not damp to the touch at the time of inspection. They are an indication of past moisture intrusion. Without inspecting this area during a prolonged period of rain we cannot determine if the leaking is still active or not. We recommend that you ask the seller for any further information and that you monitor these areas during a heavy rain and make repairs to roof exterior (such as flashing) if needed.
