## **GENERAL DESCRIPTION - EXTERIOR:**

Re: Inspection report addendum

The following maintenance items were observed during the inspection at 123 Hometown Street. The items listed here are not necessarily a part of the inspection or major defects, as described and defined in the inspection agreement. They are being listed for your convenience or at your request.

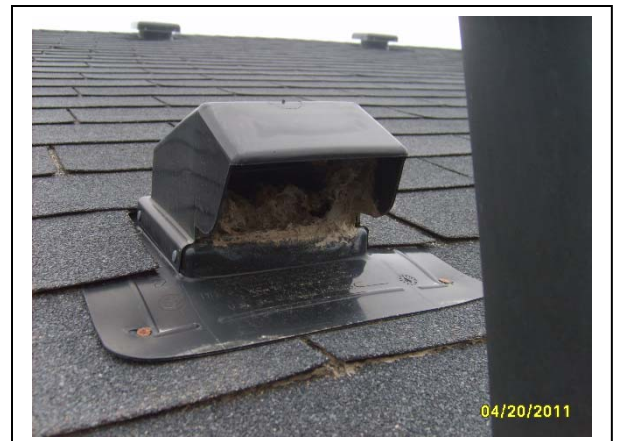
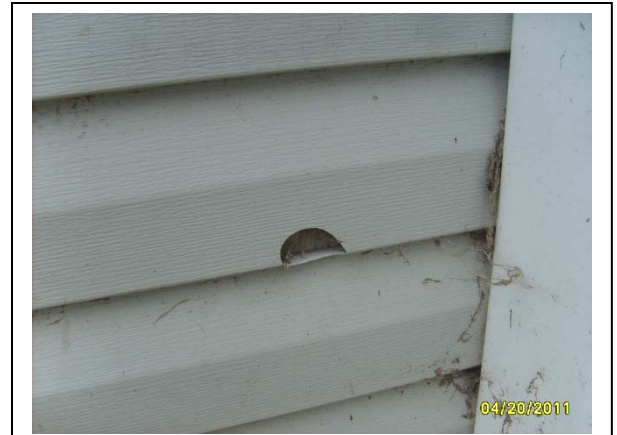
- There is some lint build-up on the roof vent for the dryer.
- There are some holes in the vinyl siding from a weed trimmer and some from impacts. Keeping water out of these holes should be a priority.

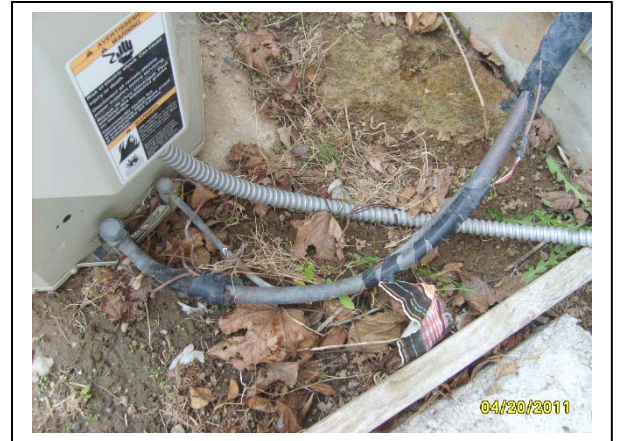
"Furnace operation OK (jets are dirty and struggle to fire sometimes).  
AC & stat wire is chewed up. Fins are mashed in on the bottom.

- The AC unit has some damage to the cooling fins. Keeping animals away from this unit is recommended. The thermostat wire has been chewed and should be repaired. Insulation is also missing from the coolant line.

Replace wire on the AC before firing off."

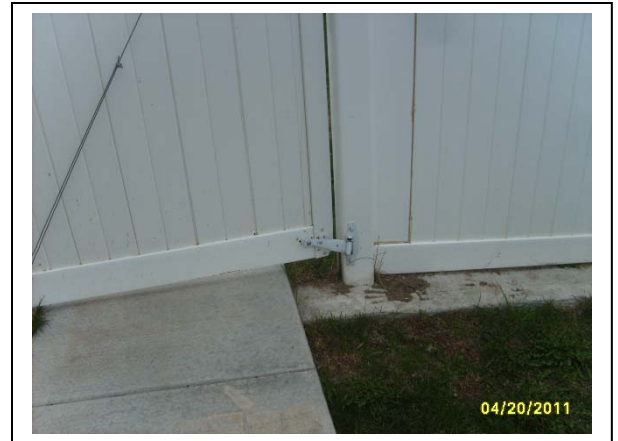
- The gate on the left side of the home is in need of repairs to the hinges and hasp.

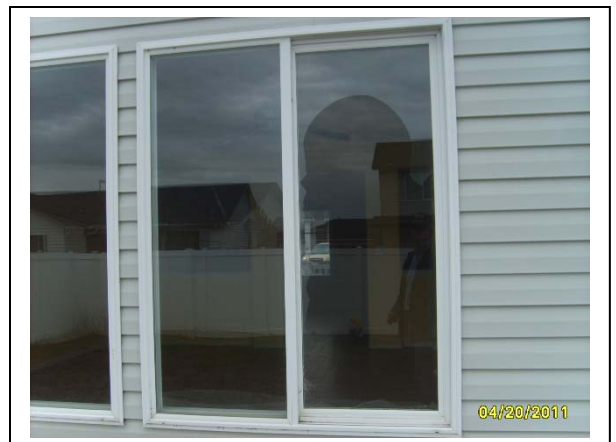
- The attic cover is missing in the garage. It can be replaced with 5/8-inch sheet rock.
- The furnace filters were clogged and were removed.
- The kitchen, master bath faucet, hall bath faucet all leak.
- The ½ bath sink drain leaks.
- The family room inner window pane and screen is broken.

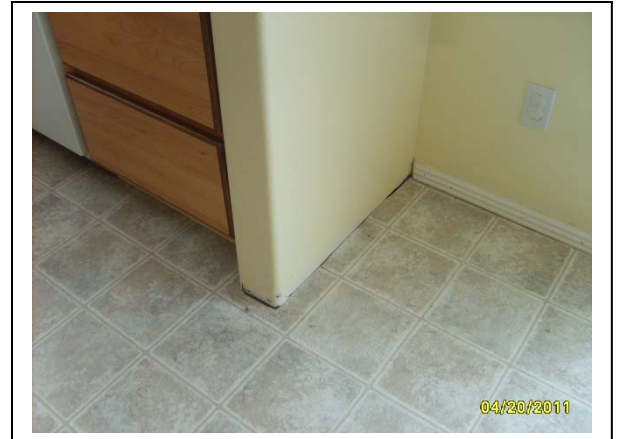
- The gas fireplace would not light. The floor valve may be turned off.
- The vinyl by the patio door, dining area and hall bath is lifting.
- There are several switch plate covers that are missing.

- Some floor trim is missing by the patio door.

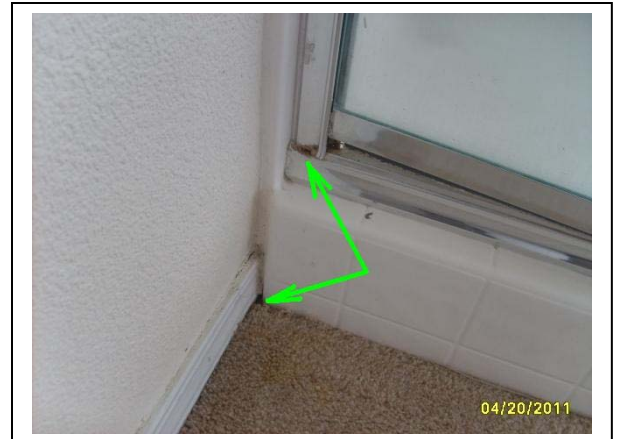
- The corner of the master shower door appears to be leaking.

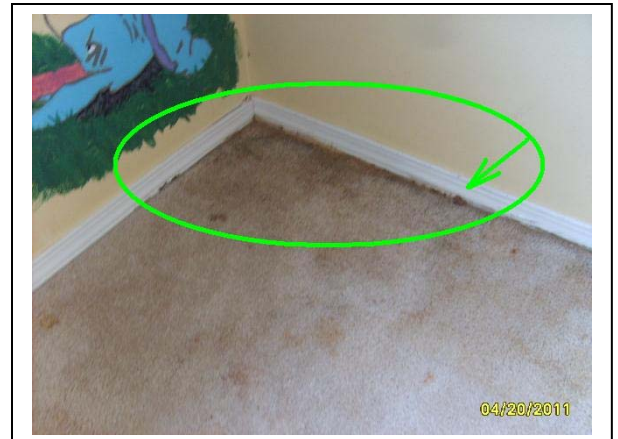
- There appears to be an active leak in the left, front corner of the roof over the "Winnie the Pooh" room. Use of a moisture meter indicated moisture in excess of 30% in some places of the wall. There are some faint moisture indications in the ceiling. There are mushrooms at the baseboard.

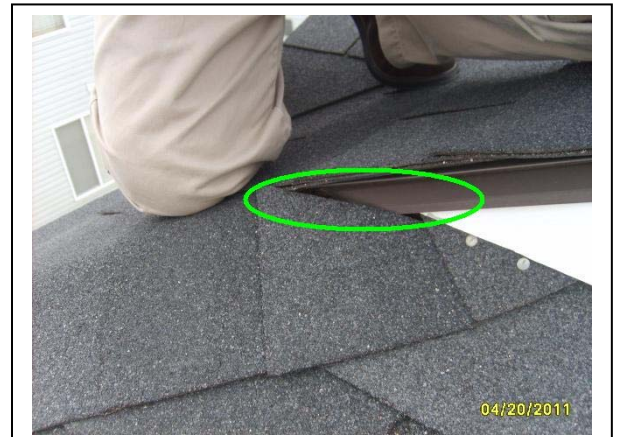
- The leak appears to be from a gap. This is the most obvious source of the leak.

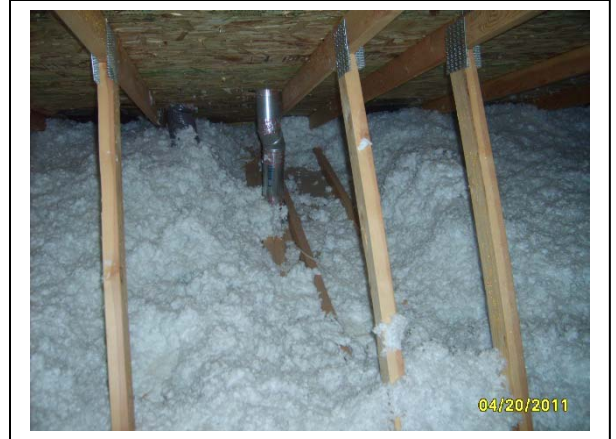
- There are a couple of places in the attic that have had the insulation moved for some work and it was not replaced.
