INSPECTION SERVICE

**RE: 2010 Opportunity Way
Anytown, IN 46000
Inspection #:
642-032010-0049**

File Number: **642-032010-0049**
Address of Inspection: **2010 Opportunity Way**

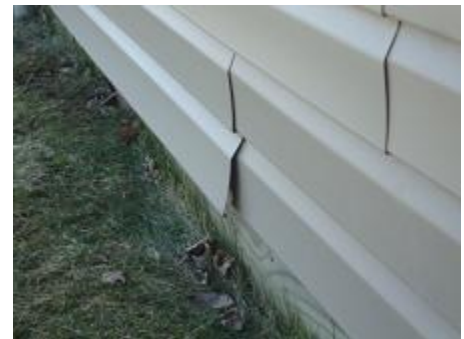
There were several areas on the siding that were loose, not fitting correctly or damaged. Damaged or improperly fitting siding can allow water intrusion which can damage the sheathing and structure. Water intrusion also promotes mold growth.

Recommend repair of the areas of the siding that are damaged, loose or not fitting correctly to prevent water intrusion.

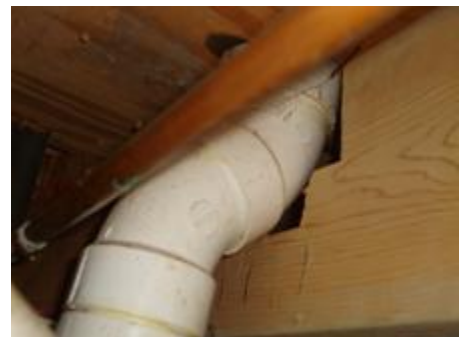
There was a floor joist that has been cut for installation of plumbing pipes. The cut joist does pose a structural concern. The joist should be repaired or replaced by a qualified contractor.

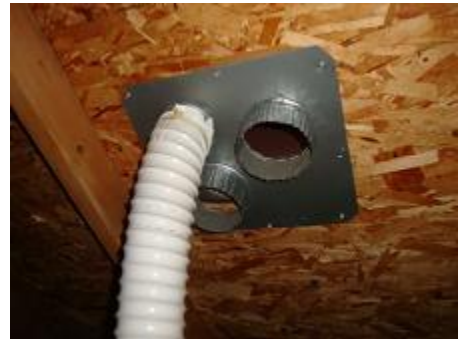
The bathroom vent flexible pipe has become disconnected in the attic space. The vent pipe is open to the attic. The vent pipe should be repaired to prevent excess moisture in the attic which can lead to deteriorating wood and mold growth.

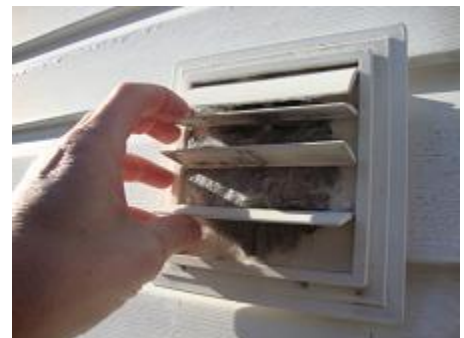
The dryer vent pipe is full of lint. This will reduce the efficiency of the dryer and is a safety hazard because it can cause the dryer to overheat. Recommend cleaning the lint from the dryer vent piping to eliminate any obstruction for safety.

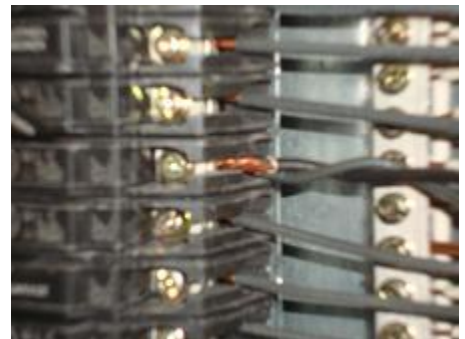
There were circuit breakers in the main electric panel that had two attached circuits. Each circuit should have its own dedicated breaker to prevent nuisance tripping and good terminal contact. One of the wires should be removed and connected to its own appropriately sized breaker by a licensed electrician.

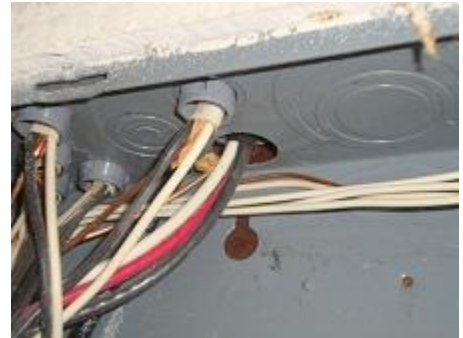
There were wire(s) entering the service panel that were not attached by appropriate box connectors. Box connectors protect the wires' insulation from the metal edge of the box and also provide strain relief. This is a safety hazard. Recommend a qualified electrician to install appropriate box connectors on all wires entering the service panel.

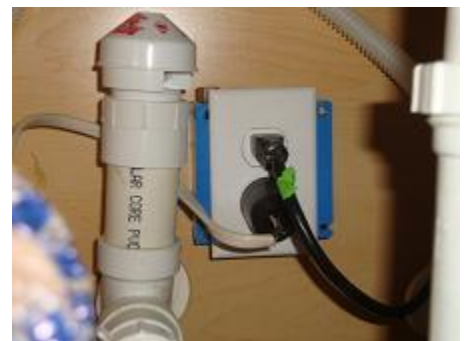
There is an outlet located under the kitchen sink that has the disposal and/or dishwasher plugged into it. It is recommended that this receptacle be GFCI protected for your safety. Recommend a qualified electrician to install a GFCI protected receptacle in this location.

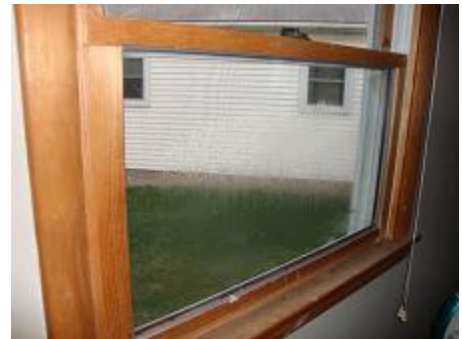
The seals on a representative number of windows in the home had failed causing a loss of vacuum between the panes and a resulting loss of insulation value. The most noticeable result of this failure is condensation and fogging between the panes of glass.

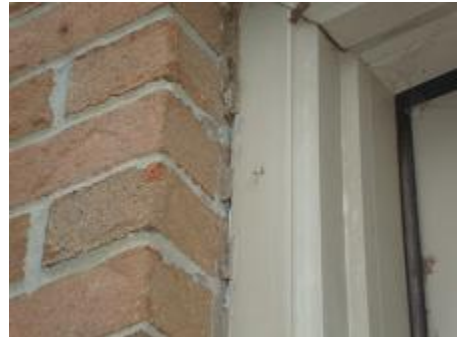
The caulking around the windows is cracked and failing. Recommend re-caulking the windows to prevent water intrusion and possible damage to the structure.
