HomeTeam
INSPECTION SERVICE

**RE: Inspection Address
Seattle, WA
Inspection #:**

GENERAL DESCRIPTION:

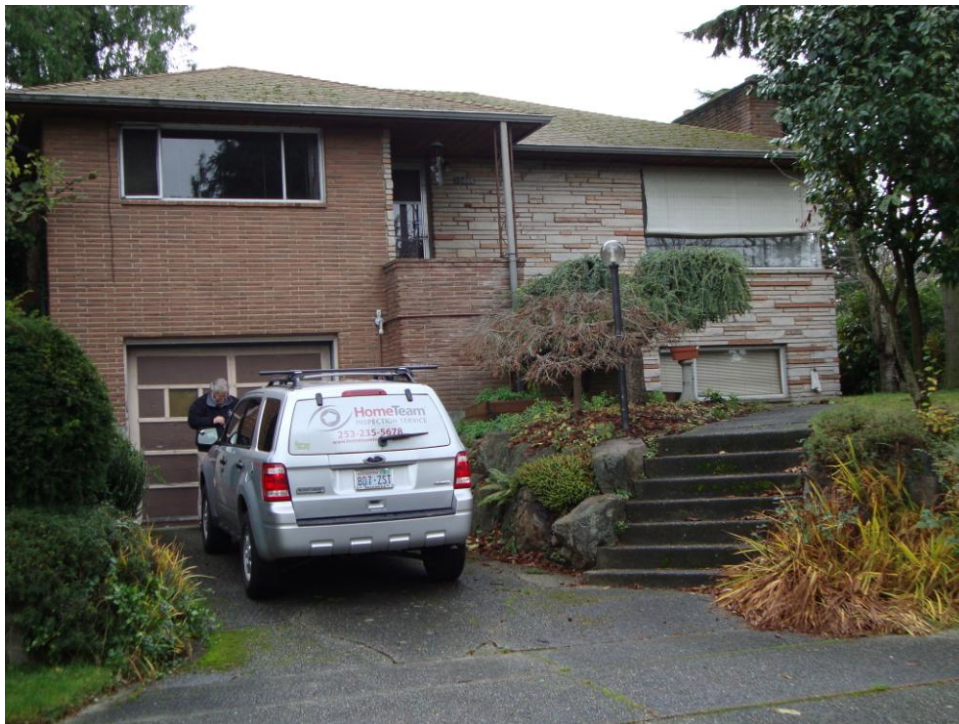
There was a concrete walkway leading to a concrete front entry way in the front of the home. There were cracks typical of the age of the home in the walkway. No major visual defects were observed in the walkway or the front entry way.

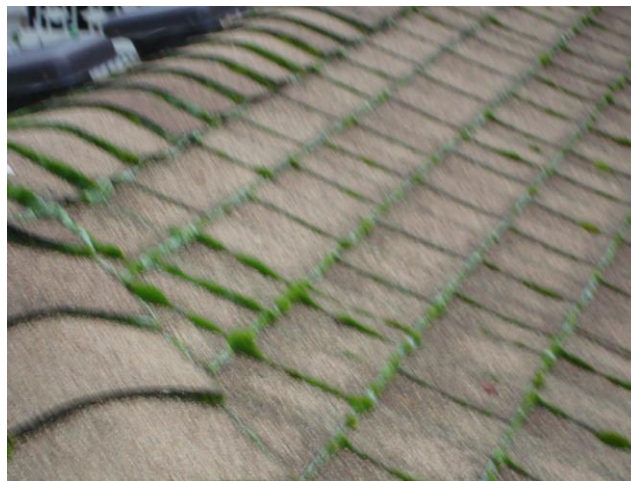
There was no curling and light surface wear observed on the roof shingles at the time of the inspection. These conditions indicate the roof shingles were in the first half of their useful life. There is light to moderate moss present on roof. Recommend monitoring for cleaning in near future.

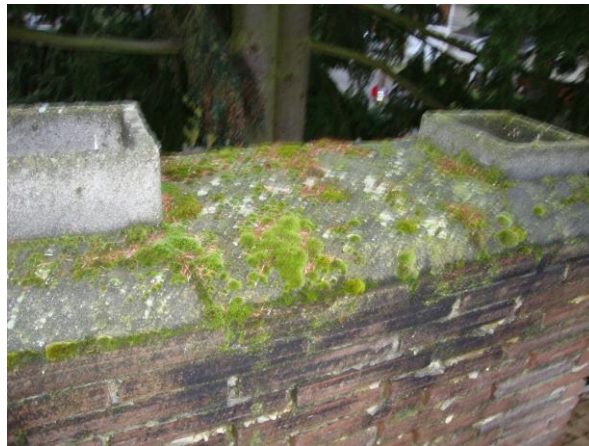
There was missing mortar in the chimney's brickwork and repairs should be made to prevent further deterioration.

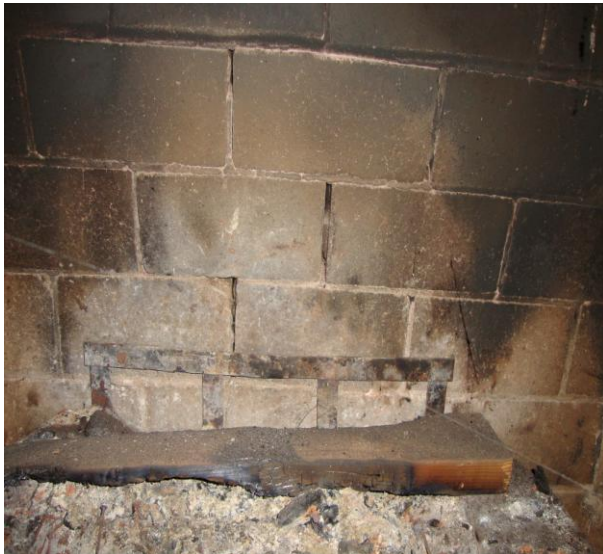
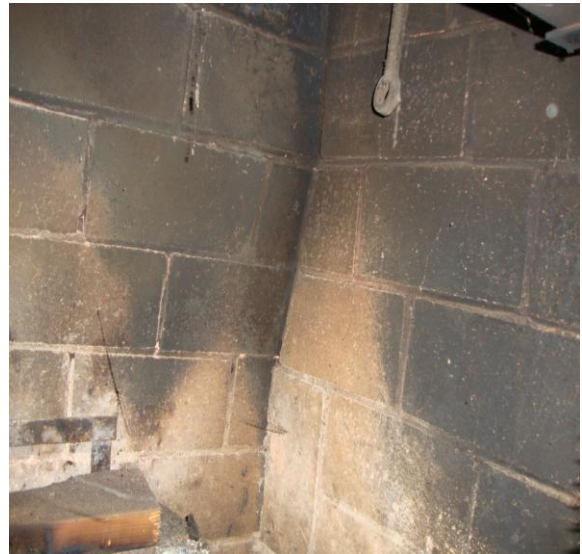
One fireplace was located in the living room on the first living level the other in the lower living level family room. The both dampers did appear to be functional with heavy debris falling through when opened. There was visual evidence of creosote buildup in both fireboxes and/or chimneys. There were large spaces between firebricks observed in the both fireboxes.

Recommend cleaning and evaluation by a licensed fireplace professional/chimney sweep.

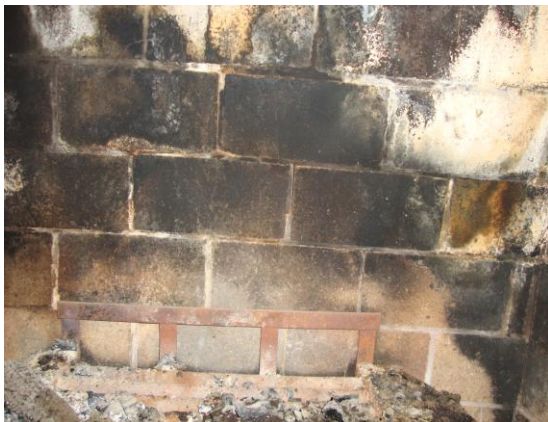
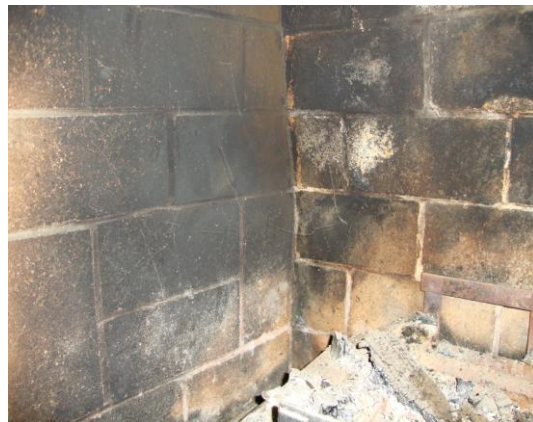
The back of the firebox in the living room exhibited efflorescence on the back wall indicating water leakage through the chimney.

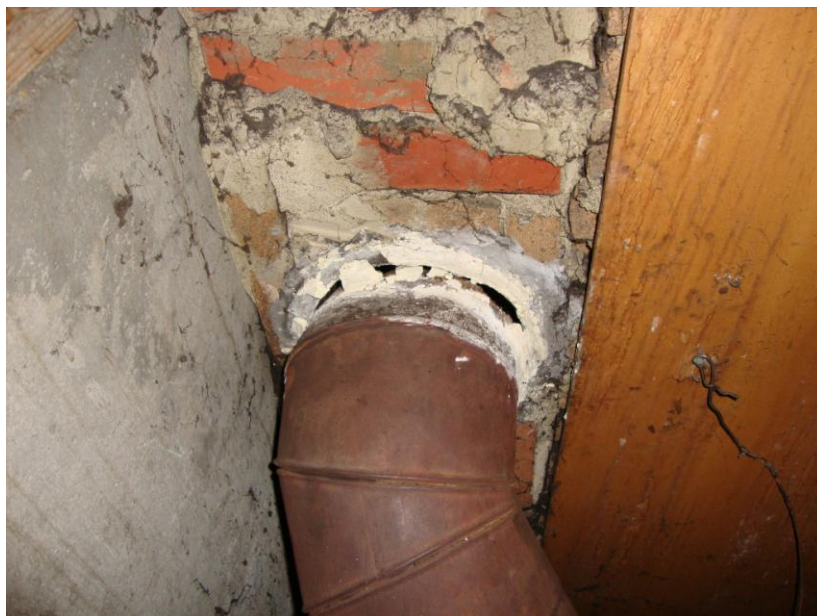
The exhaust vent pipe is separated from the wall, allowing burnt gases to escape to the basement. This is a safety issue and needs to be corrected.
