March 3, 2010

**RE: 111 Any St
Blanchard, OK 73010
Inspection #: 456-032010-0071**

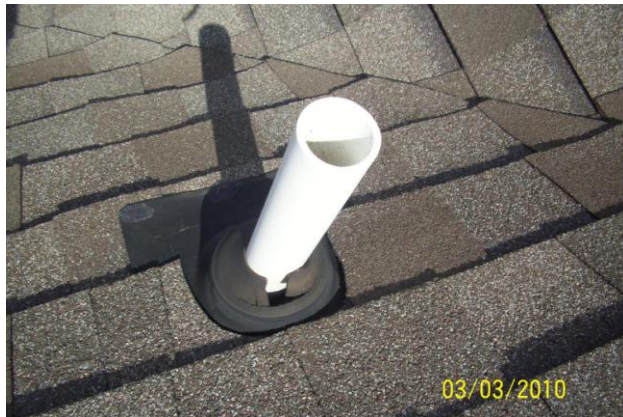
The roof was a gable design covered with asphalt/fiberglass shingles. Observation of the roof surfaces and flashing was performed from ground level with the aid of binoculars and/or by walking the accessible portions of the roof covering if the conditions allow. Steeply pitched roofs, wood shake roofs, slate roofs, and wet or snow covered roofs are not mounted for safety reasons. Asphalt shingles should not have foot traffic during extreme temperatures that could cause the shingles to break from being too cold or to leave impressions due to being too hot. The roof was mounted. The age of the roof covering, as reported by the seller's disclosure, was approximately 08 years. There appeared to be one layer of shingles on the roof at the time of the inspection. There was no curling and light surface wear observed on the roof shingles at the time of the inspection. These conditions indicate the roof shingles were near the middle of their useful life. **Defect: The two plumbing vents on the west side of the roof need new collars.**

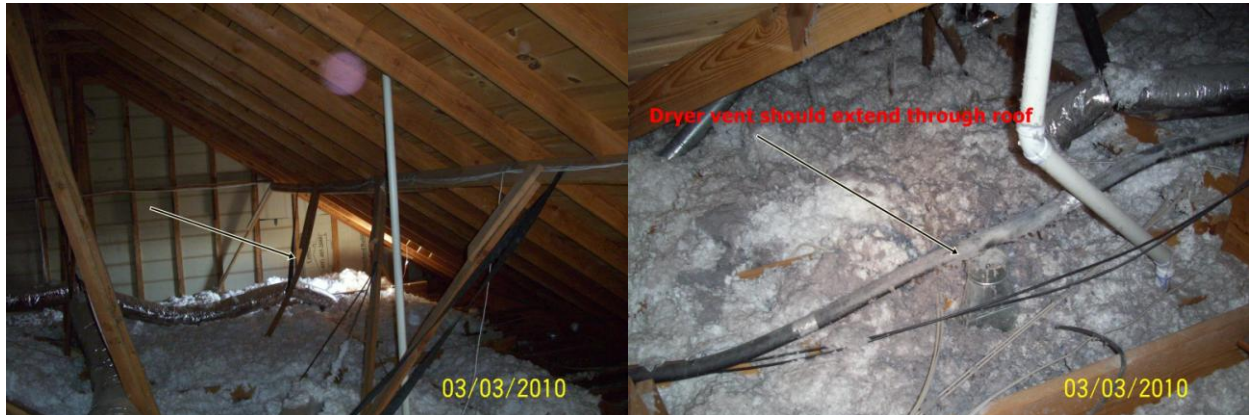
The attic was accessed through a scuttle in the garage. The attic above the living space was insulated with loose-fill insulation, approximately 6-8-inches in depth. Ventilation throughout the attic was provided by gable, soffit, and power vents. The roof structure consisted of two-inch by six-inch wood rafters spaced 24 inches on center and wood planks sheathing. **Defect: The Purlin support was failing on the SE side of the**

attic. It should be replaced with a properly installed stud. The attics scuttle ladder needs the lower end repaired. There was little to no insulation over the converted garage. The dryer was venting into the attic and should be extended through the roof.

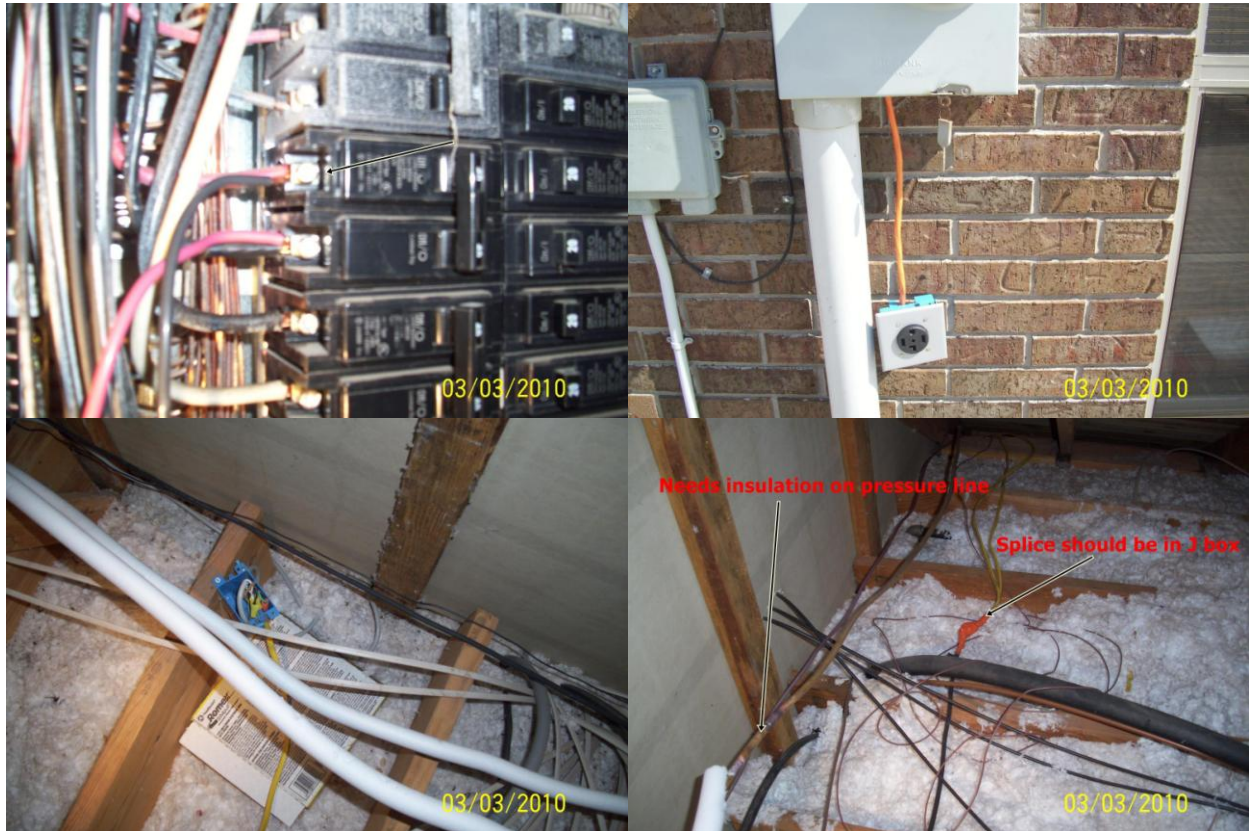
The underground electric service entrance cables entered the home on the left side. The electric meter was located on the left exterior wall. The service wires entered a Cutler Hammer service panel, located on the garage wall with a 200 amps and 120/240 volt rated capacity. The 120-volt branch circuits within the panel were copper. The branch circuits and the circuit breaker to which they were attached did appear to be appropriately matched. The visible house wiring consisted primarily of the Romex type. To kill the power to the home, 200-amp main breaker in the service panel must be turned off. **Defect: There were open splices in the attic that should be enclosed in junction boxes. There were one or more breakers that were double tapped. This can cause nuisance tripping of the double tapped breakers and loose connection can also be a problem if the wires are not securely fastened or the breaker is not**

designed for double tapping. The 240-volt outlet on the exterior needs to be a weatherproof outlet and the wiring should be in conduit. This appeared to be the wiring that was double tapped into the 40 amp breaker which is oversized for these wires.

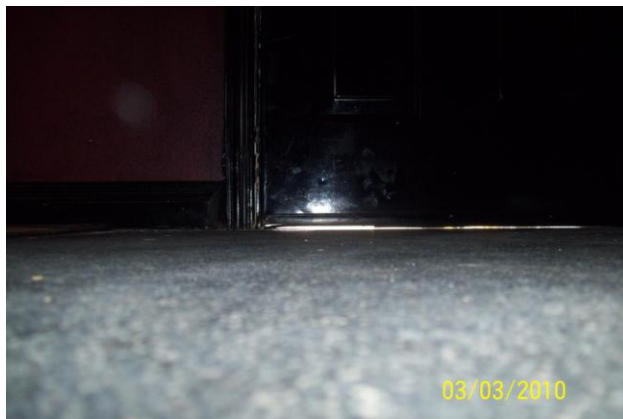
All accessible doors were inspected. Doors are considered to be functional if they open, close, and lock without undue difficulty. Weather stripping issues are considered normal maintenance and may be noted but are not written up as a repair item unless they are significantly defective. The exterior door locks should be changed or rekeyed upon occupancy. **Defect: The side garage door has a large gap at the bottom. The master bathroom door had a hole in it.**

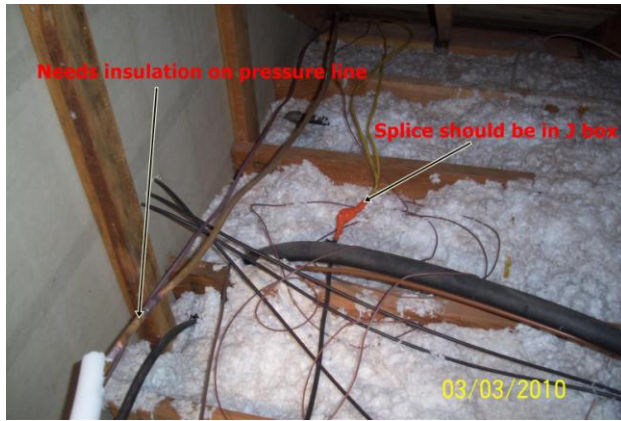
There was a ductless HVAC system for the converted garage. It did appear to be functional. **Defect: The pressure lines for the ductless HVAC system were not fully insulated in the attic and could sweat into the ceiling.**
