HomeTeam INSPECTION SERVICE

**RE: 1234 Rural Avenue
Hometown, IN 46000
Inspection #:
642-062009-0003**

File Number: **642-062009-0003**
Address of Inspection: **1234 Oak Street**

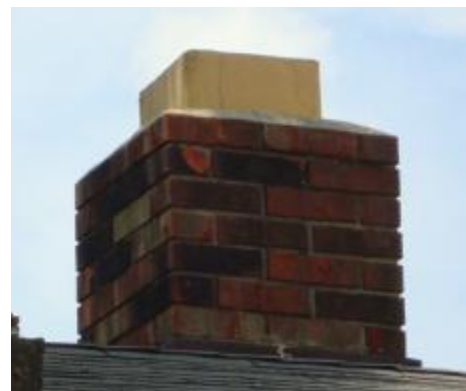
There was missing mortar in the chimney's brickwork and repairs should be made to prevent further deterioration.

There was no rain cap on the chimney. This device will help to prevent rainwater and snow from entering the flue and causing water damage.

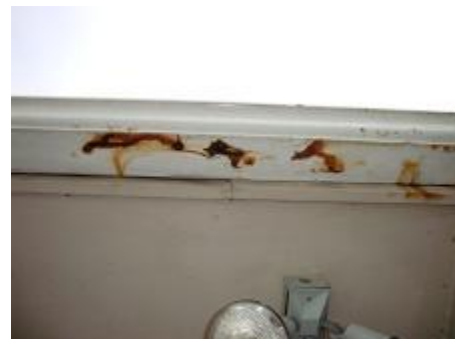
The roof drainage system consisted of steel gutters and downspouts which appeared to be functional but in need of repair at the time of the inspection. There are holes rusted through the bottom of the gutter over the deck on the right rear of the home. A potential safety issue exists with the gutter leak being directly over the outside light.

- A potential safety issue exists with the gutter leak being directly over the outside light.

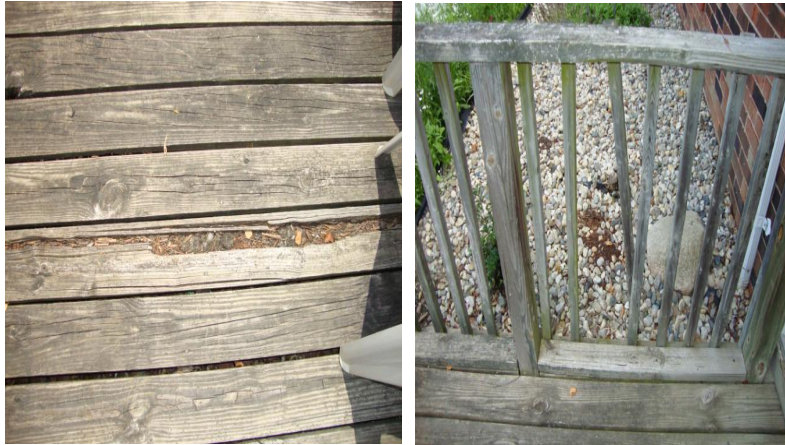
There was a wood deck located on the right side of the home. There appeared to be significant deterioration of the wood. The railing around the deck and stairs was not securely attached to the deck or stairs.

There were major visual defects observed on the

visible portions of the deck or support structure. For safety reasons, this deck should be repaired or replaced by a qualified contractor before use.

- There was a wood deck located on the right side of the home. There appeared to be significant deterioration of the wood. The railings around the deck and stairs was not securely attached to the deck or stairs. A wood deck should be cleaned and sealed regularly to prevent deterioration. There were major visual defects observed on the visible portions of the deck or support structure. For safety reasons, this deck should be repaired or replaced by a qualified contractor before use.

A wood deck should be cleaned and sealed regularly to prevent deterioration.

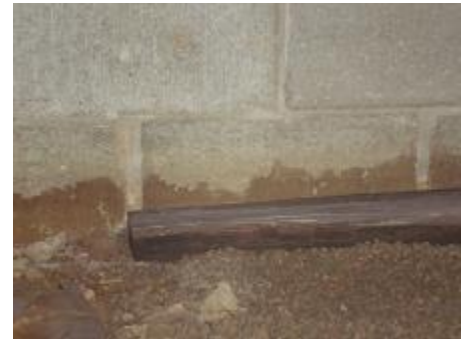
The crawl space was accessible at the time of the inspection, and was dry, but evidence exists of prior water intrusion. The attached photo shows the water mark on the foundation wall which is evidence of prior water intrusion. Because of its configuration, it was not possible to inspect all areas of the crawl space. The west foundation wall under the family room was inaccessible due to a large heating/cooling duct. A crawl space should have a polyvinyl vapor barrier covering the surface and should be adequately vented at all times. There was adequate ventilation in the crawl space. There were no major visual defects observed in the crawl space.

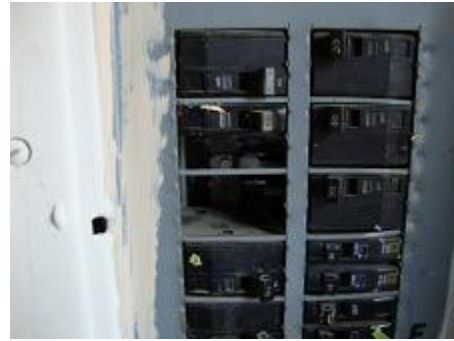
There were missing breaker knockout covers (the protective covers over the wires inside the panel) in the main electric panel. For safety, the open slots in the panel should be covered to prevent possible contact with an energized portion of the panel.

- There were missing breaker knockout covers (the protective covers over the wires inside the panel) in the main electric panel. For safety, the open slots in the panel should be covered to prevent possible contact with an energized portion of the panel.

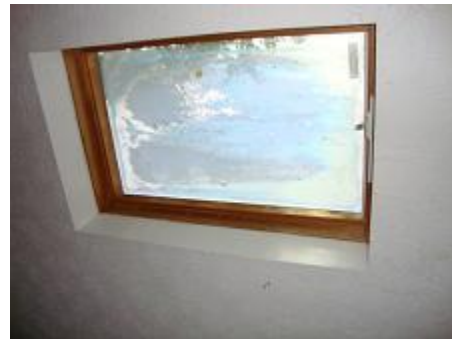
The seals on the two skylights in the sun-room had failed causing a loss of vacuum between the panes and a resulting loss of insulation value. The most noticeable result of this failure is condensation and fogging between the panes of glass.
