**RE: 555 Sample Dr.
Sample, OH 45069
Inspection #: 001-000000-0000**

File Number: **001-000000-0000**
Address of Inspection: **555 Sample Dr.**

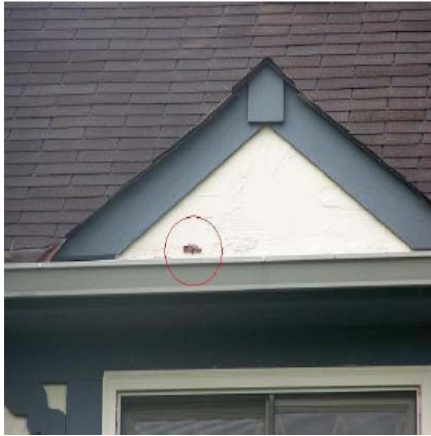
NOTE: The top left dormer has areas of stucco that need to be sealed. The rear right side of the home, where the stucco meets the cedar one by six wood trim, needs to be sealed. The rear door frame for the sliding door has areas that need to be monitored and/or sealed.

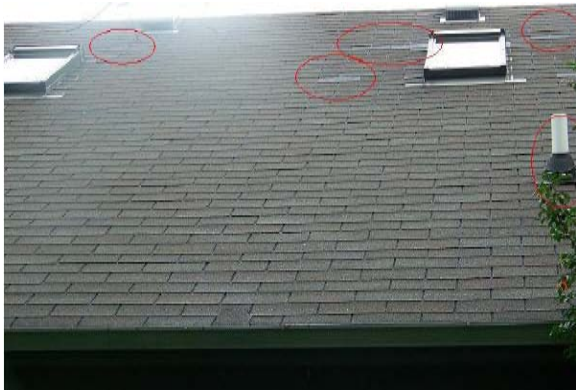
The flashing boot collar around the drain waste vent pipe was deteriorating and should be replaced or repaired to stop or prevent water intrusion.

There were a represented of shingle tabs missing throughout the roof at the time of the inspection. Missing shingle tabs is not necessarily a sign of a roof leak. Consult with a qualified roofer to make repairs.

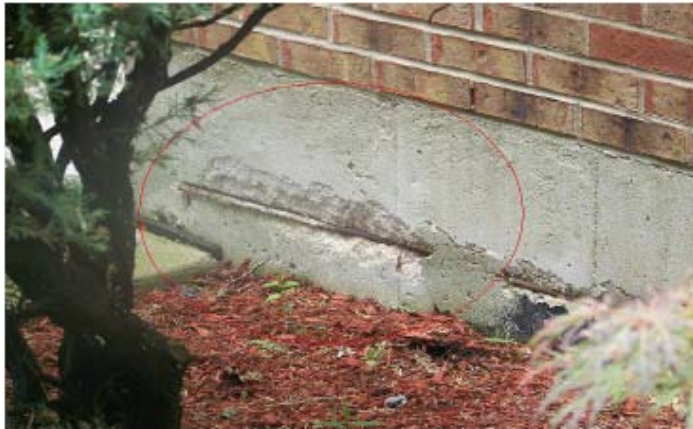
NOTE: The right side of home has an area on the concrete foundation that should be sealed.

There was normal settlement cracks observed on the foundation. These cracks did not appear to have any structural significance at the time of the inspection. There were no major visual defects observed on the visible portions of the foundation.

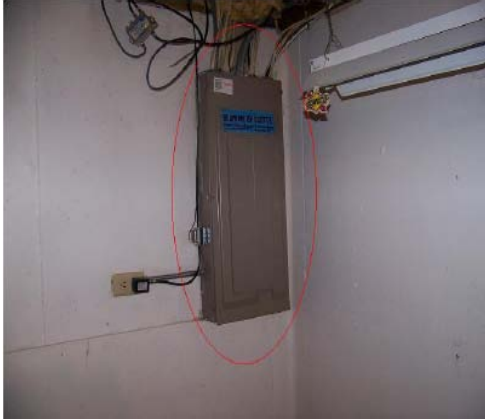
NOTE: Cover plate for the service panel box needs to be properly secured to the panel. There is a double tapped breaker in the service panel box. The basement ceiling has a receptacle that should be properly installed into a junction box.

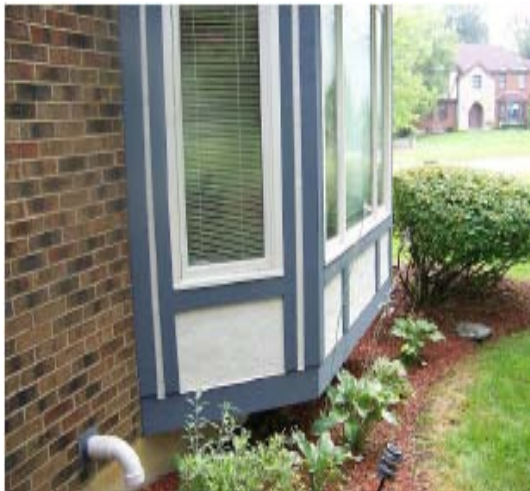
NOTE: The rear bay window should be sealed where frame meets brick siding.

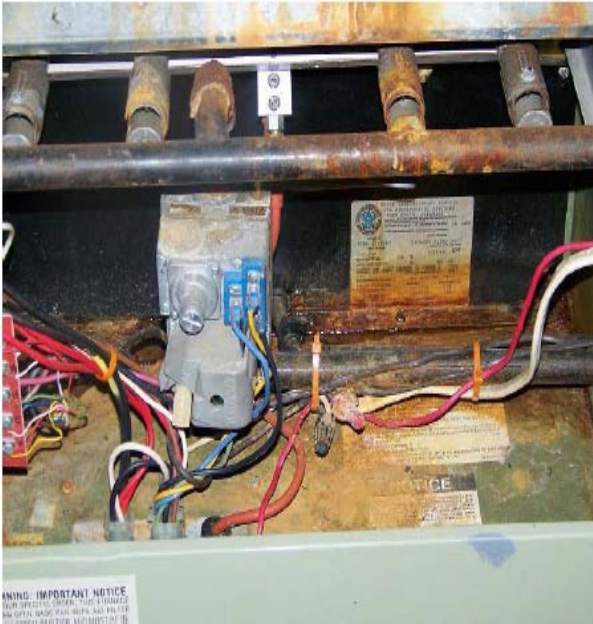
The home was heated by Rheem natural gas forced air furnace. The unit was located in the basement of the home and has an approximate input heating capacity of 100,000 BTUH.

The heating system was functional at the time of the inspection but should be cleaned and serviced due to the apparent lack of previous maintenance and rust.
