File Number: **505-0000-0000**

Address of Inspection: **Anywhere USA**

### **GENERAL DESCRIPTION:**

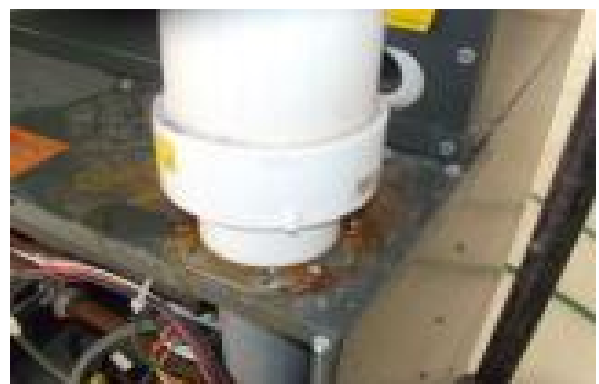
The PVC exhaust flues were inspected and there was a leak at the PVC pipe at the furnace in the basement. Repairs are advised.
