HomeTeam
INSPECTION SERVICE

**RE: 9876 Missionary Drive
New Place, GA 44678
Inspection #: 206-092009-6789**

File Number: **206-092009-0065**

Address of Inspection: **9876 Missionary Drive, New Place, GA 44678**

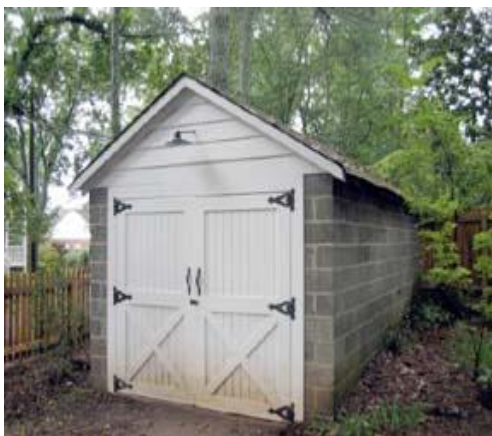
The detached garage was designed for one car with access provided by barn-style doors. The garage ceiling and walls were unfinished. The gravel garage floor was in good condition. The roof structure of the garage was 2" x 4" wood rafters, with wood plank sheathing. The roof was asphalt-fiberglass shingles. The shingles had serious wear and serious curling. Moss was growing on the shingles. Parts of the sheathing were wet and deteriorating. The roof age was not disclosed. **The roof leaked.**

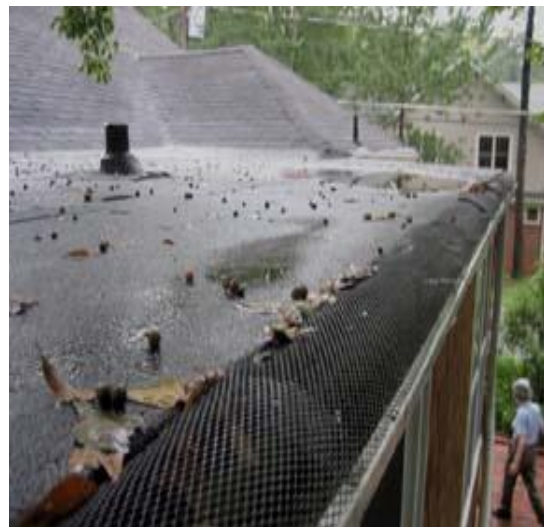
There was light to moderate curling and

moderate wear observed on the roof surface. These conditions and its age indicate the roof covering is in the latter stages of its useful life.

The roofing system should be further evaluated by a licensed roofing contractor to determine its condition and the cost of repair or replacement, if necessary.

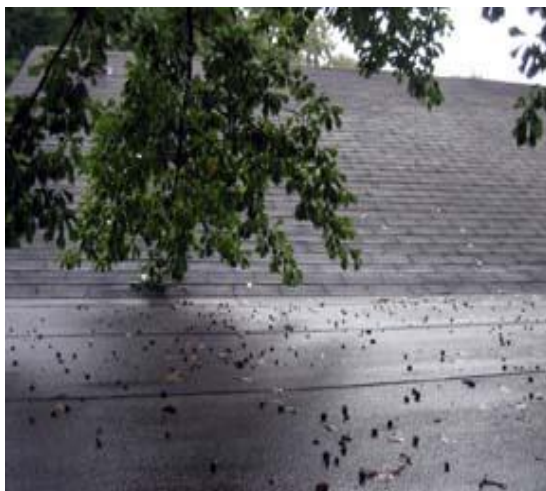
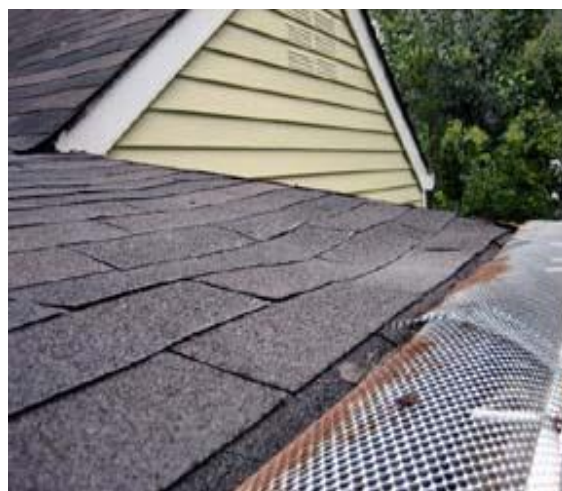
Uneven surfaces were observed on several areas of the roofs. Based on the inspection of the attic, no defect in the sheathing was noted. Although this condition did not appear to be causing any roof surface failure at the time of the inspection, it may reduce the useful life of the roofing material along seams.

Tree limbs were in contact with, or very near, the roof. Friction of trees against the roof can damage the roofing material. Tree limbs should be pruned away from the roof.

An accumulation of leaves, twigs, moss or other debris was noted on the roof. This material should be removed as it can shorten the useful life of the roof covering.

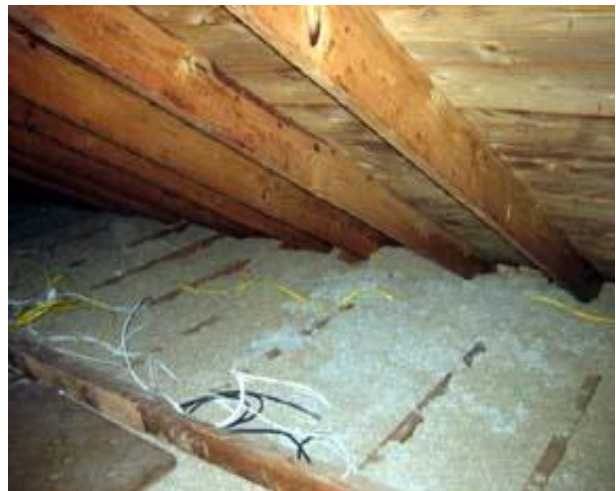
The insulation appeared to be vermiculite. Vermiculite ore from some sources is known to contain asbestos; however asbestos is not intrinsic to vermiculite. The presence of asbestos cannot be confirmed without professional testing.

Disturbance of vermiculite insulation has the potential to release asbestos fibers, if present, into the air. The Environmental Protection Agency considers exposure to asbestos to be a cause of lung cancer and other adverse health effects. For more information, see website <http://www.epa.gov/asbestos/>. In addition to consulting the

EPA and state and local health departments, it is recommended not to disturb the vermiculite insulation and, when possible, to limit exposure in the areas this substance is found .

Prior to remodeling or conducting any renovations that would disturb the insulation, it is recommended to hire professionals trained and certified to test for and handle asbestos for safe removal or remediation if necessary.

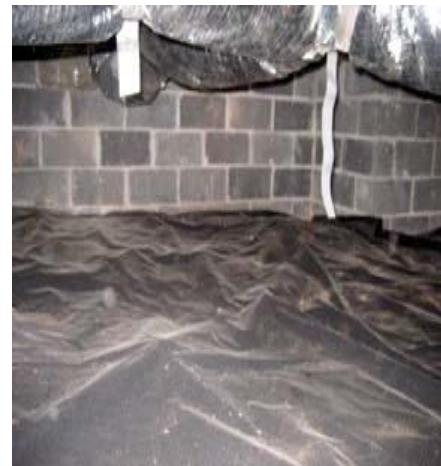
The foundation was constructed of concrete block. Several minor cracks were observed on the foundation. A single inspection cannot determine whether movement of a structure has ceased. Any cracks should be monitored regularly.

There was efflorescence on the wall. Efflorescence is a powdery deposit often seen on masonry walls when water seepage has occurred. It is mineral salts in the masonry that dissolve in the water as it passes through the wall. It is evidence of previous moisture in a crawlspace or basement.

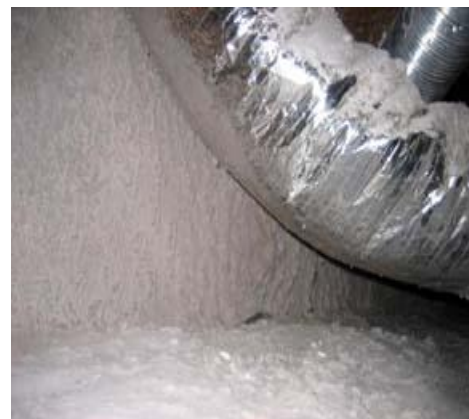
The crawl space of the home was accessible at the time of the inspection, and was dry. Because of its configuration, it was not possible to inspect all areas of the crawl space. A crawl space should have a polyvinyl vapor barrier covering the surface and should be adequately vented at all times. There was a vapor barrier covering the surface of the soil. Ventilation in the crawlspace appeared adequate.

The clothes dryer vent terminated in the crawlspace. The vent should be extended to the exterior of the home to avoid exhausting moist air and lint from the dryer into the crawlspace.

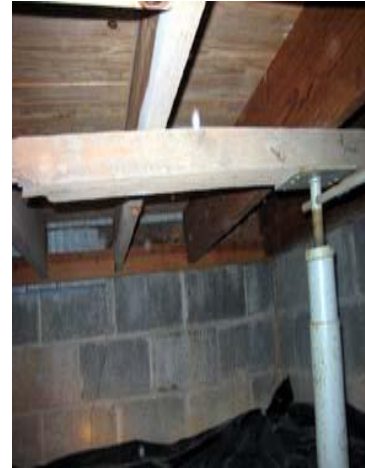
The floor and joists under the hall bathroom had deteriorated wood joists, subfloor and wall stud. At the time of inspection, the wood was dry. There were additional piers and lateral supports in this area. The joists had been repaired. The subfloor and wall stud had not been replaced.

Support posts, lateral supports, and previous repairs and additions should be evaluated by a licensed general or framing contractor for proper sizing and repair.

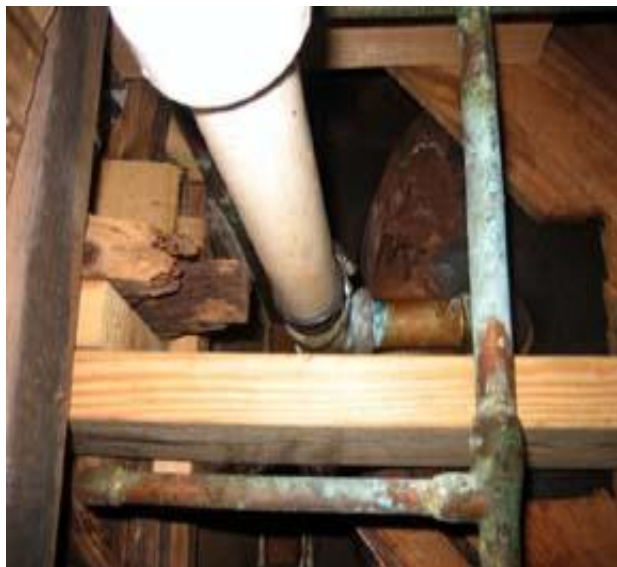
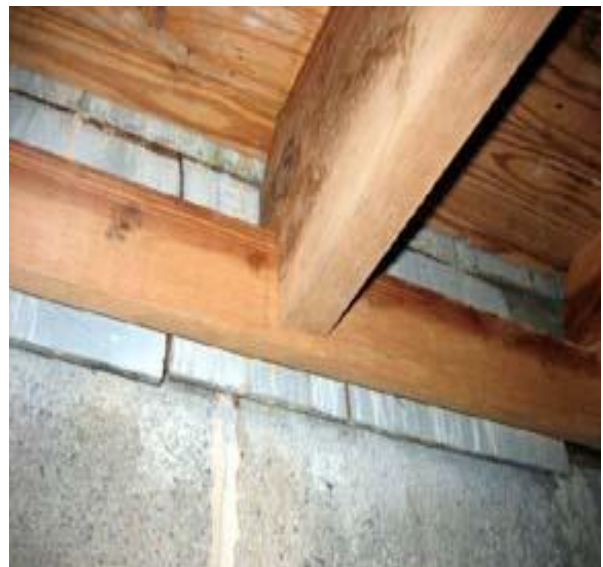
The rear room beside the kitchen appeared to be an addition to the original structure. Two-by-eight-inch floor joists for that room were supported by a two-by-four-inch ledger nailed to the house over wood siding. It could not be determined what this ledger was attached to. ***The ledger should be bolted to the house structure.***

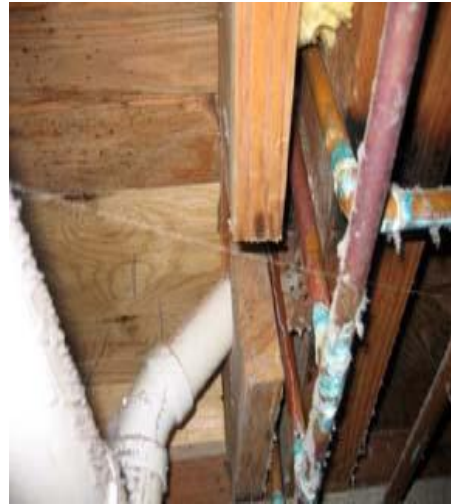
One or more joists had been cut and not properly repaired. We recommend repair by a qualified carpenter.

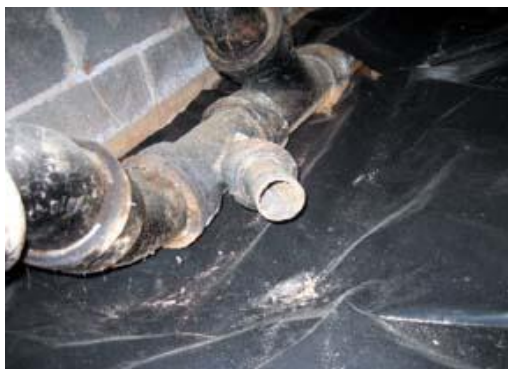
An open wastewater drain was observed under the house. It was dry at the time of inspection, but the line should be capped to prevent waste water intrusion into the crawlspace.
