HomeTeam
INSPECTION SERVICE

**RE: 6441 Pulpit Rock Dr.
Colorado Springs, Co 80918
Inspection #: 586-012010-0028**

File Number: **586-012010-0028**
Address of Inspection: **6441 Pulpit Rock Dr.**

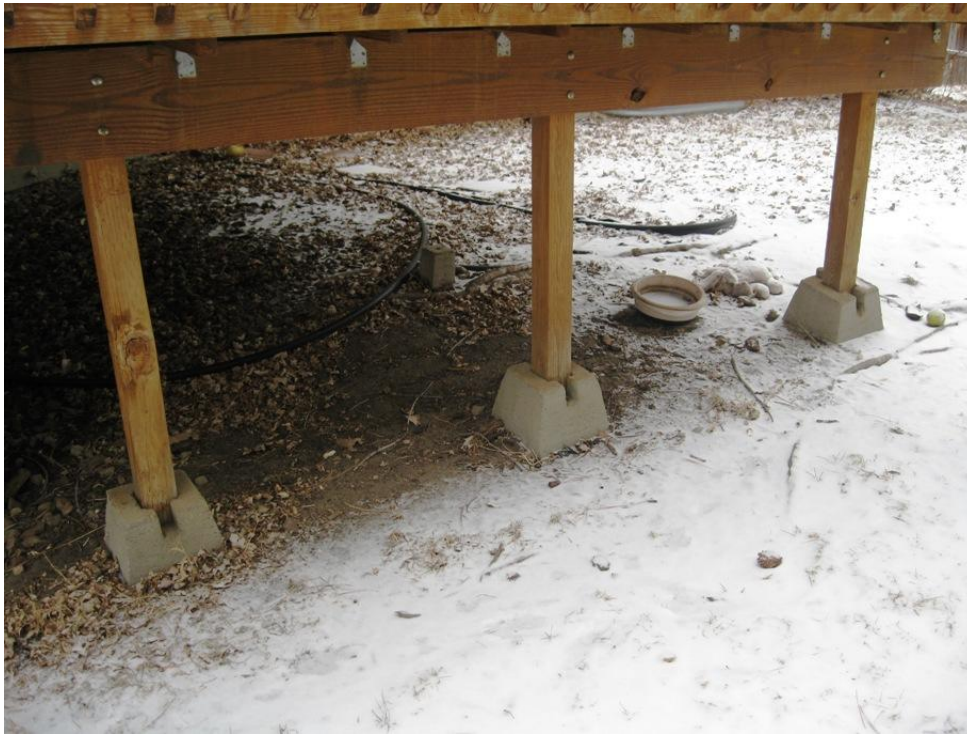
The deck piers however, were only constructed of temporary concrete footers which are considered to not properly support the deck structure according to normal construction practices. These type of footers are subject to freezing and premature failure. We recommend that the deck be evaluated and repaired as necessary by a reputable contractor prior to closing. See attached photo on the next page of this report.

Deck supports are not standard construction type

- There was a wood deck located in the back of the home. There did not appear to be significant deterioration of the wood. The main deck header was bolted to the home using properly sized lag bolts. The deck joists were properly attached to the structure with joist hangers. The deck boards were properly attached to the deck joists using wood screws.
- The deck piers however were only constructed of temporary concrete footers which are considered to not properly support the deck structure according to normal construction practices. These type of footers are subject to freezing and premature failure. We recommend that the deck be evaluated and repaired as necessary by a reputable contractor prior to closing.
