HomeTeam
INSPECTION SERVICE

Inspection Summary for: Anywhere Oklahoma

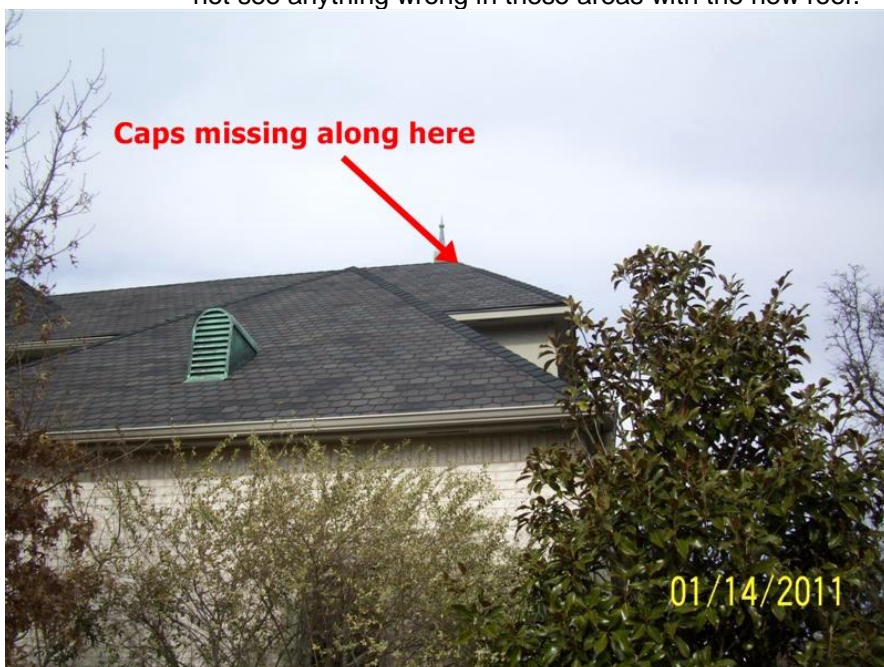
- a. There were missing ridge Capps on the upper SE hip of the roof that need to be replaced. Note: There were ceiling stains in a couple of areas of the home. They are likely from the previous roof, as we could not see anything wrong in these areas with the new roof.

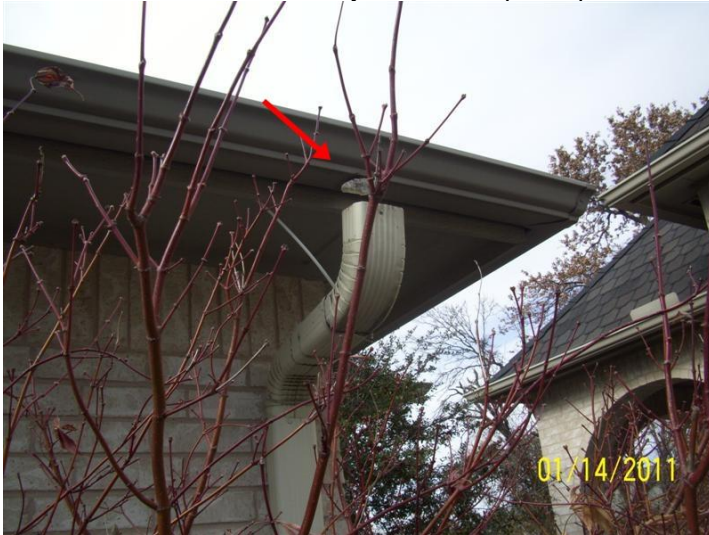
- a. The downspouts were disconnected from the gutters in a couple of places around the rear side of the home. The dryer vent damper cap was missing on the exterior wall.

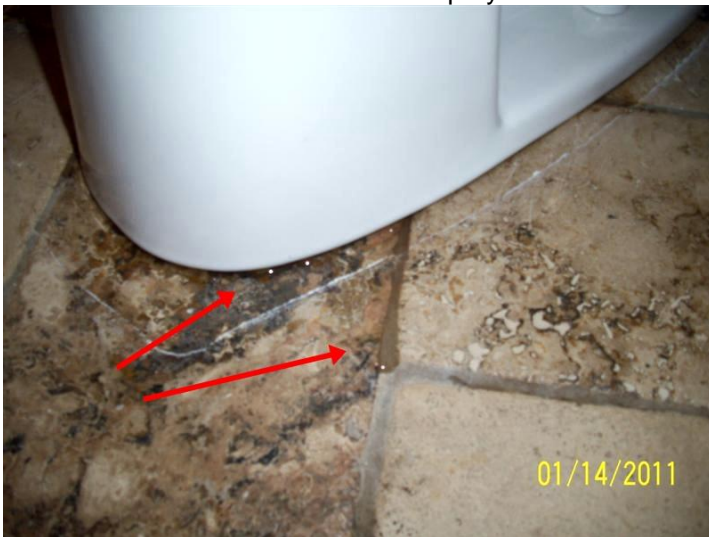
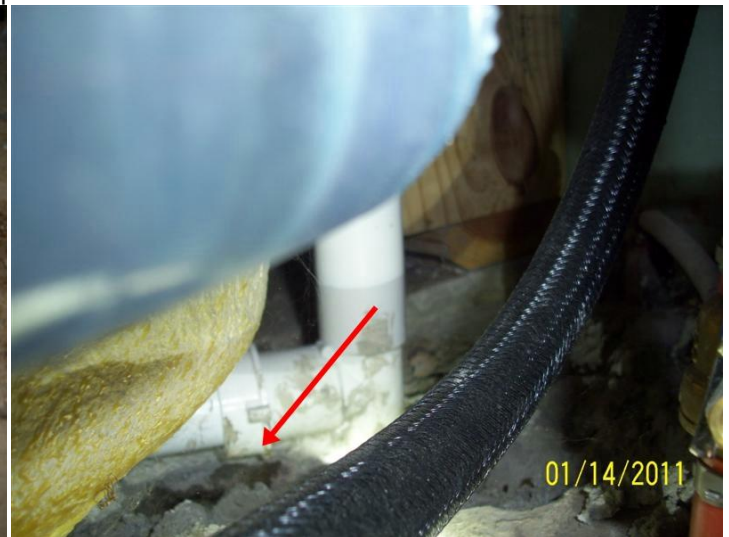
- a. The toilet seal is leaking around the base of the toilet in the NE lower level bathroom.
- b. The drain stopper was not functional in the upper level SW bathroom.
- c. The drain for the jetted bathtub leaks under the tub in the master bath.
- d. The NE hose faucet sprays out of the anti siphon valve with a hose connected.

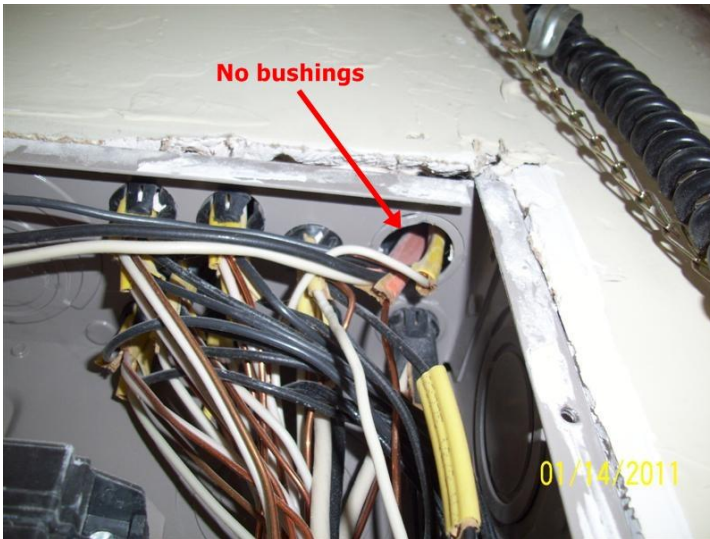
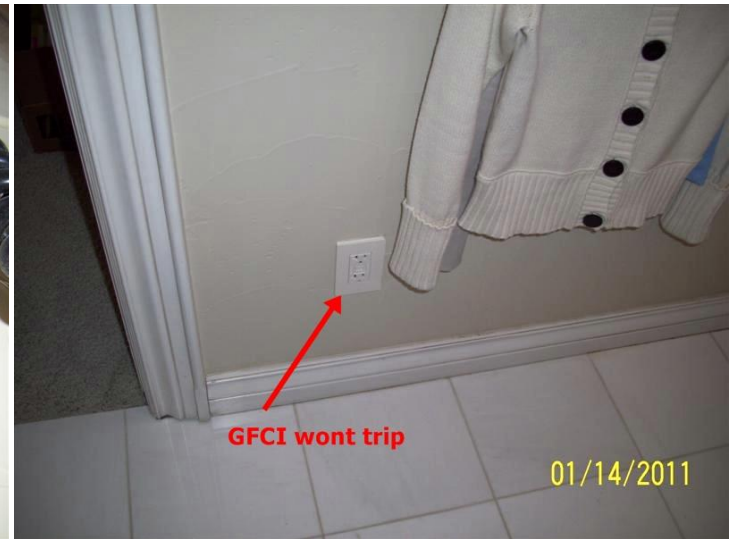
- a. There were wires in the 200-amp service panel that were missing the wire bushings.
- b. The GFCI outlet that is on the lighting circuit in the upper NW bathroom was not functional.
- c. The outlets on the bar counter in the game room should be GFCI protected and were not.
- d. There was a missing outlet cover in the study. \
- e. The service panel covers had pointed screws for fasteners.
See next page

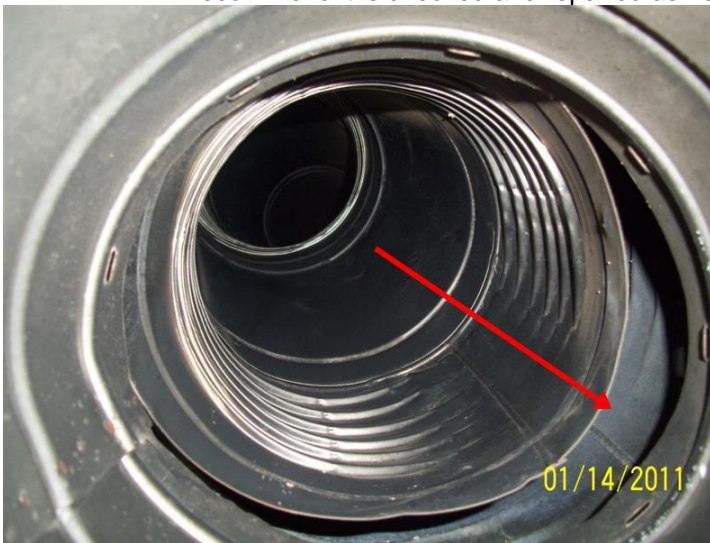
- a. It appeared that the fireplace vent was not properly connected in the rear family room fireplace. I recommend it is checked and repaired as needed by a qualified fireplace contractor.

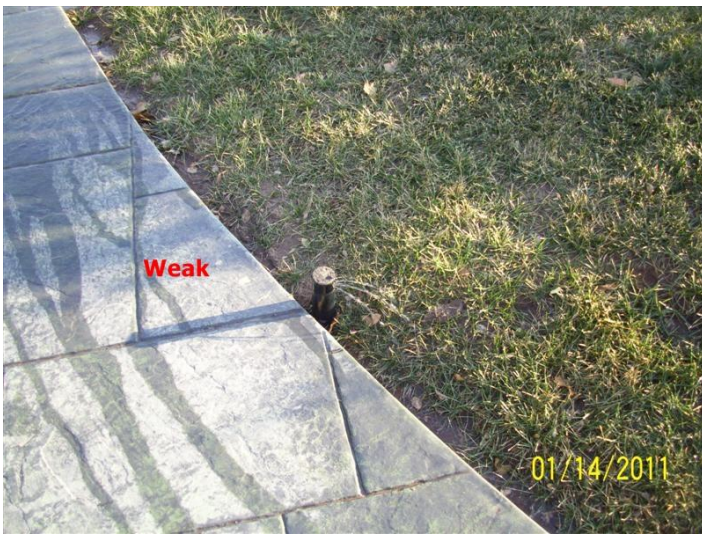
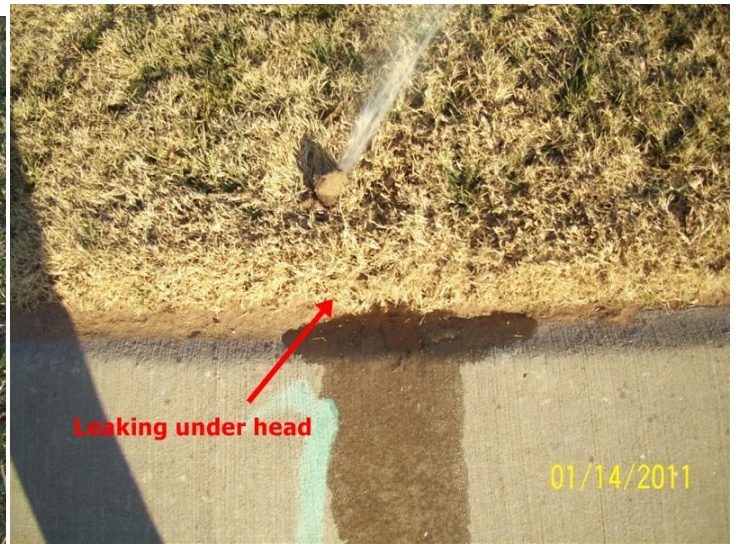
- a. Most of the sprinkler heads appeared to be leaking around the base of the heads.
- b. There were several heads that had little to no water flow and others that were broken.

10. SPRINKLER SYSTEM: Cannot estimate due to the number of heads leaking and more investigation needed. The entire system needs to be checked and repaired as needed by a qualified sprinkler system contractor.

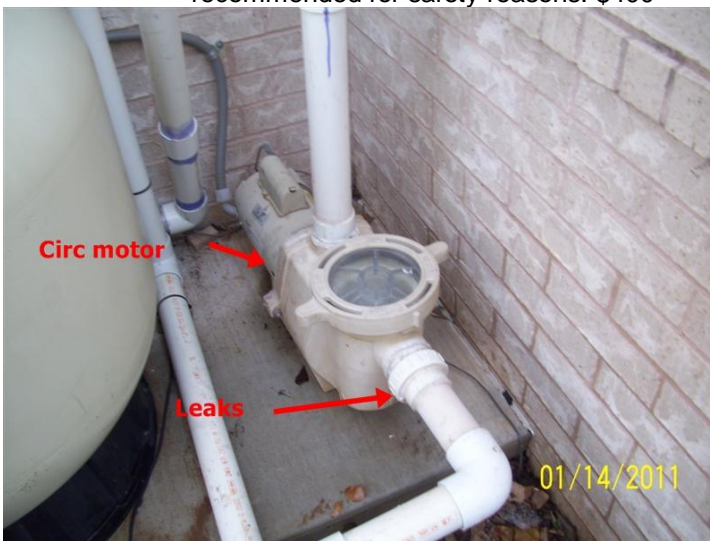
- a. The circulating pump was sounded as if the bearings are about to go bad. The plumbing to the pump was also leaking at the pump. \$600
- b. The vac motor was missing a water plug. \$10
- c. There was a wireless controller for the pool equipment. It did not appear to be functional. ??
- d. The blower for the spa did not appear to be functional. \$400
- e. The skimmer basket cover was cracked \$30
- f. The gates to the back yard pool area were not self closing. Self closing gates that latch on their own are recommended for safety reasons. \$400
