Home Inspection Report

File Number: **555-555-55555**
Address of Inspection: **1111 New Home Drive**

**RE: 1111 New Home Drive
Erie, PA 16504
Inspection #: 555-555-55555**

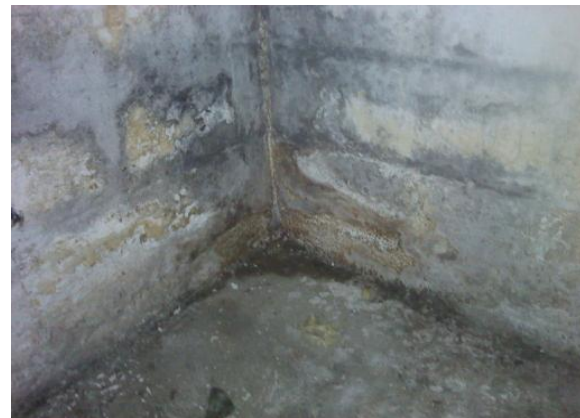
The basement was mostly dry at the time of the inspection. Many water stains were visible on the walls. Indications of past moisture were present on the floor. A musty odor was present. Efflorescence (a crusty white-ish residue on masonry walls) was not visible on the walls. A few signs of past flooding were visible at this time.

Because the basement is below grade, there exists a vulnerability to moisture penetration after heavy rains or melting snow. Most of the water problems in basements are a result of improper grading and neglected gutters and
