**RE: 555 Sample Dr.
Sample, OH 45069
Inspection #: 001-000000-0000**

File Number: **001-000000-0000**
Address of Inspection: **555 Sample Dr.**

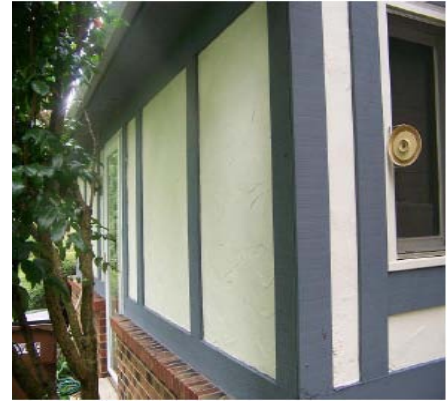
NOTE: The top left dormer has areas of stucco that need to be sealed. The rear right side of the home, where the stucco meets the cedar one by six wood trim, needs to be sealed. The rear door frame for the sliding door has areas that need to be monitored and/or sealed.

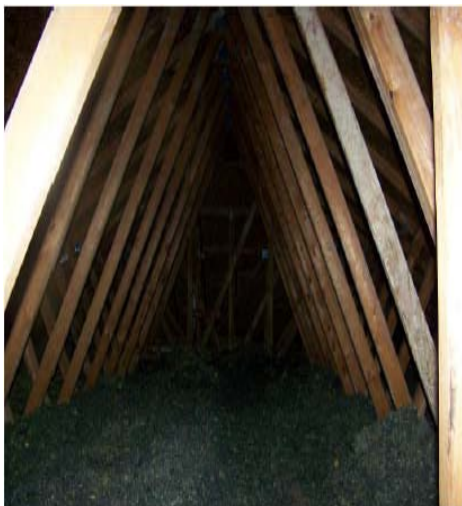
The attic was accessed through a scuttle in the 2nd floor bedroom closet. The attic above the living space was insulated with blown insulation, approximately 6-inches in depth.

Ventilation throughout the attic was provided by soffit and roof vents. The roof structure consisted of two-inch by six-inch wood trusses and rafters spaced 16 inches on center and OSB (wafer board) sheathing.

There was no moisture visible in the attic space. The absence of visible indications of moisture is not necessarily conclusive evidence that the roof is free from leaks. The only way to be sure a roof does not leak is to inspect the underside of the roof during a heavy rain. There were no major visual defects observed in the attic or roof structure.
